Figure 5a. A site map showing the location of the high-resolution magnetic surveys conducted in the Big Chief Mobile Home Park in the City of Hutchinson in 2003.

Figure 7. The total field component of magnetic anomaly from the bottom sensor at the Big Chief Mobile Home Park, Hutchinson, Kansas.

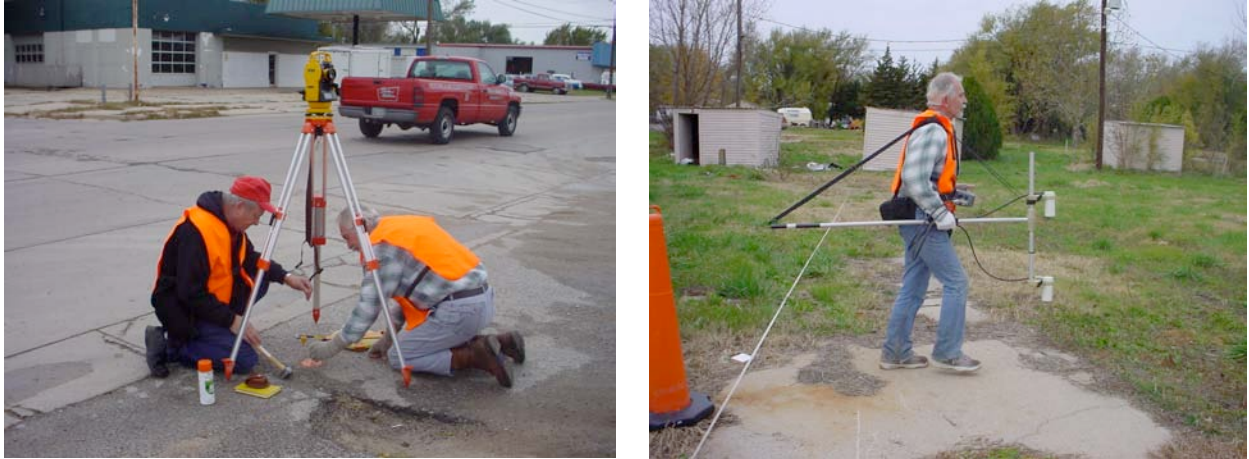
Figure 1. A theodolite (left) was used to define grids for high-resolution magnetic survey. James Kelly and Ron Wilson was setting up the theodolite. A portable cesium gradiometer G858 (right) was used to measure the total component of the geomagnetic field. Ron Wilson was performing the magnetic survey.

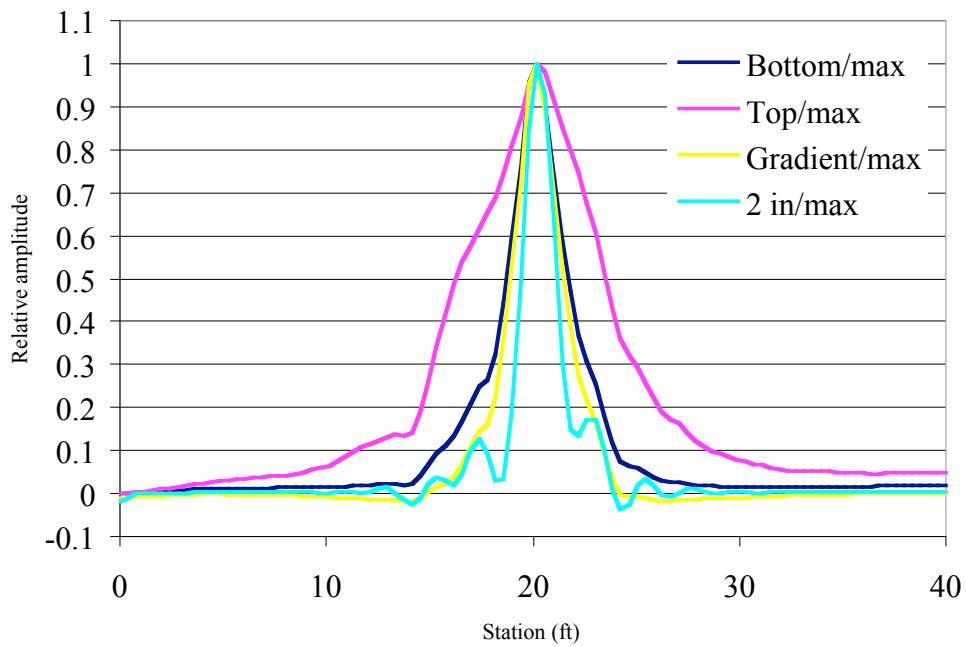
Figure 3e. The central profiles of magnetic data shown in Figure 3a-3d. The narrower anomaly peaks are, the higher the horizontal resolution.

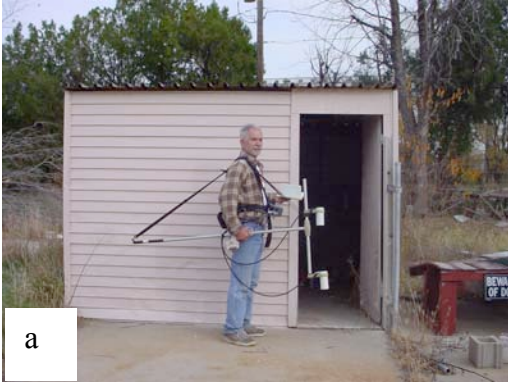
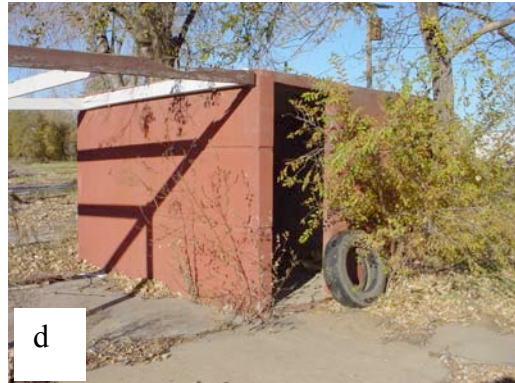
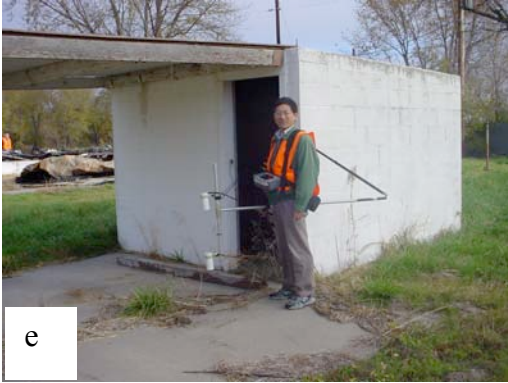
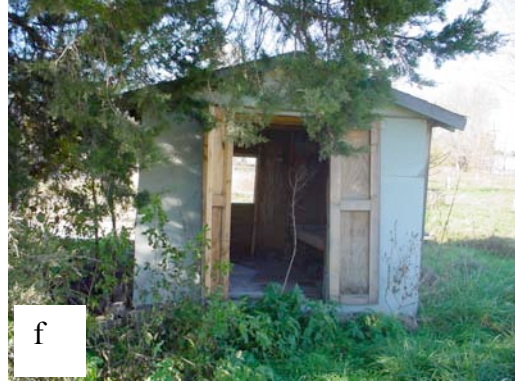
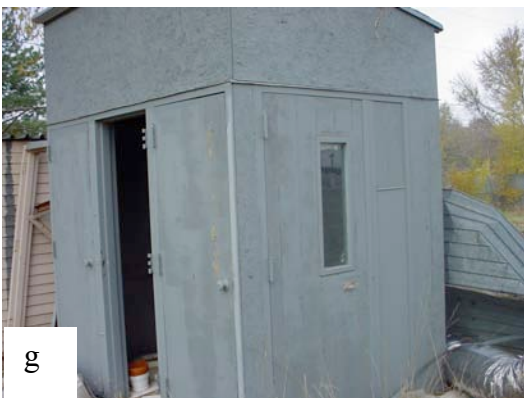
Figure 11. Sheds made of seven different materials in the Big Chief Mobile Home Park, Hutchinson, Kansas. a. Type-I metal sheets. b. Type-II metal sheets. c. Type-III metal sheets. d. Concrete. e. Bricks. f. Wood. g. A shed with metal door and metal beams. Ron Wilson and Jianghai Xia were acting as a scale in the photos.

Type-I metal sheets			
Name of shed	Relationship	Reading (nT)	Notes
BC13-1	$x_1 > x_2$	37,000	in Grid 13, made of type-I metal sheets
BC13-2		44,000	x_i, y_i are the coordinates of shed i in the grid
BC15-1	$y_1 < y_2$	40,000	If not metioned, sheds were made of type-I metal
BC15-2	$x_3 > x_2$ or x_1	39,000	sheets. See photo 1999, 2015
BC15-3		42,000	
BC16-1		40,000	
BC17-1	$y_1 < y_2$	40,000	
BC17-2		39,000	
BC18-1		43,000	
BC19-1	$y_1 < y_2$	39,000	
BC19-2		38,000	After shed removed, reading was 53,000
BC20-1		36,000	A dryer inside
BC21-1	$x_1 > x_2$	38,000	
BC21-2		40,000	
BC22-1		35,000	
BC23-1	$y_1 < y_2$	42,000	After shed removed, reading was 52,500
BC23-2		39,000	
BC24-1		41,000	
BC26-1	$x_1 < x_2$	37,000	
BC26-2		41,000	
BC26-3	$y_3 > y_2$ or y_1	37,000	
BC27-1	$x_1 < x_2$	35,000	
BC27-2		38,000	
BC28-1	$y_1 < y_2$	37,000	Another shed in Grid 28 BC28-2
BC29-1		36,000	
BC30-1	$y_1 > y_2$	39,000	
BC30-2		38,000

Type-II metal sheets			
BC45-1	$x_1 < x_2$	48,000	Type-II metal sheets. photo 2008, 2016
BC55-1		43,000	Type-II metal sheets. photo 2008
BC60-1		45,000	Type-II metal sheets. photo 2008
BC64-1		44,000	Type-II metal sheets. photo 2008
Type-III metal sheets			
BC49-1	$y_1 > y_2$	52,000	Type-III metal sheets. photo 2013
BC49-2		52,000	Type-III metal sheets. photo 2013
Concrete			
BC42-1		42,000	Concrete. photo 2010
BC46-1		53,000	Concrete. photo 2010
BC47-1		49,000	Concrete. photo 2010
BC48-1		47,000	Concrete. photo 2010
BC61-1		48,000	Concrete. photo 2010
BC63-1		48,000	Concrete. photo 2010
Bricks			
BC28-2		52,000	Shed is made of bricks. photo 1997
BC36-1		53,000	Bricks. photo 1997
Wood			
BC35-1	$x_1 < x_2 < x_3$	49,000	Wood walls and a metal roof.
BC45-2		52,000	Wood. photo 2009
BC35-3		25,000	Metal beam and metal door. photo 1989

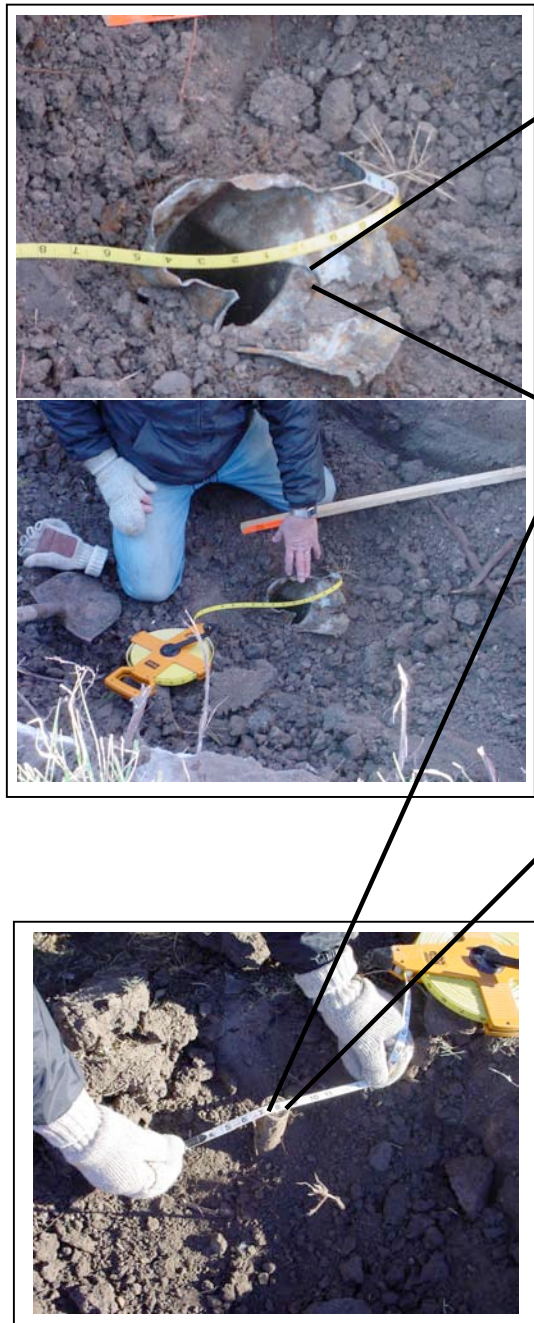
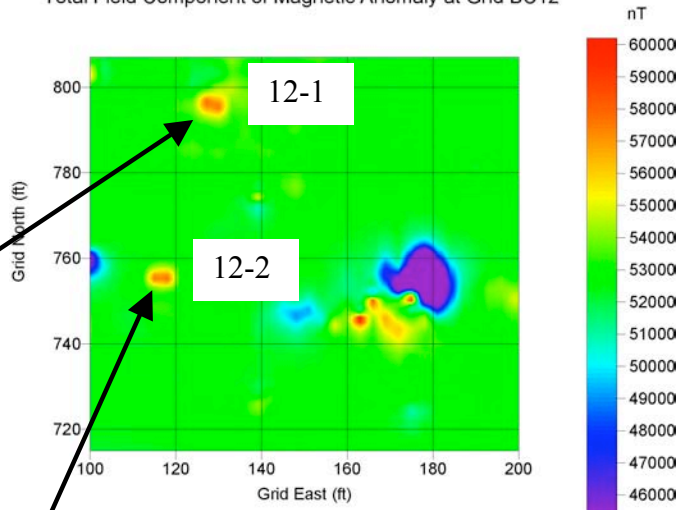
Figure 12. A 5” water well (129, 796) at a depth of 2 ft (top, left). A 1.5” gas pipe (117, 755) at 3 ft depth (bottom, left). The total field component of the magnetic anomaly and gradient data of Grid 12 (right).

Grid #	Anomaly #	X	Y	Amplitude (nT)	Half-width (ft)	Gradient (nT/in)	Source	Photo #
A. Vertical pipes/rebar								
	1	1	57	26	62,740	3	230a 1.5" gas pipe (vertical)	2046
	1	2	81	7	57,050	2	150a 1.25" pipe (vertical)	2047
	12	1	129	796	57,360	3	120a 5" water well, 2' deep	2079-2080
	12	2	117	755	57,330	2	150a 1.5" gas pipe (vertical), 3" deep	2077-2078
	32	2	293	1114	58,160	2	100a 1" gas pipe (vertical)	2055
	47	1	219	687	58,290	2	160a rebar, 3" deep (vertical)	2082-2083
	66	2	478	744	60,960	2	120a 1" gas pipe (vertical)	2042
	66	4	487	801	57,290	1.5	140a 1" elec. pipe (vertical)	2044-2045

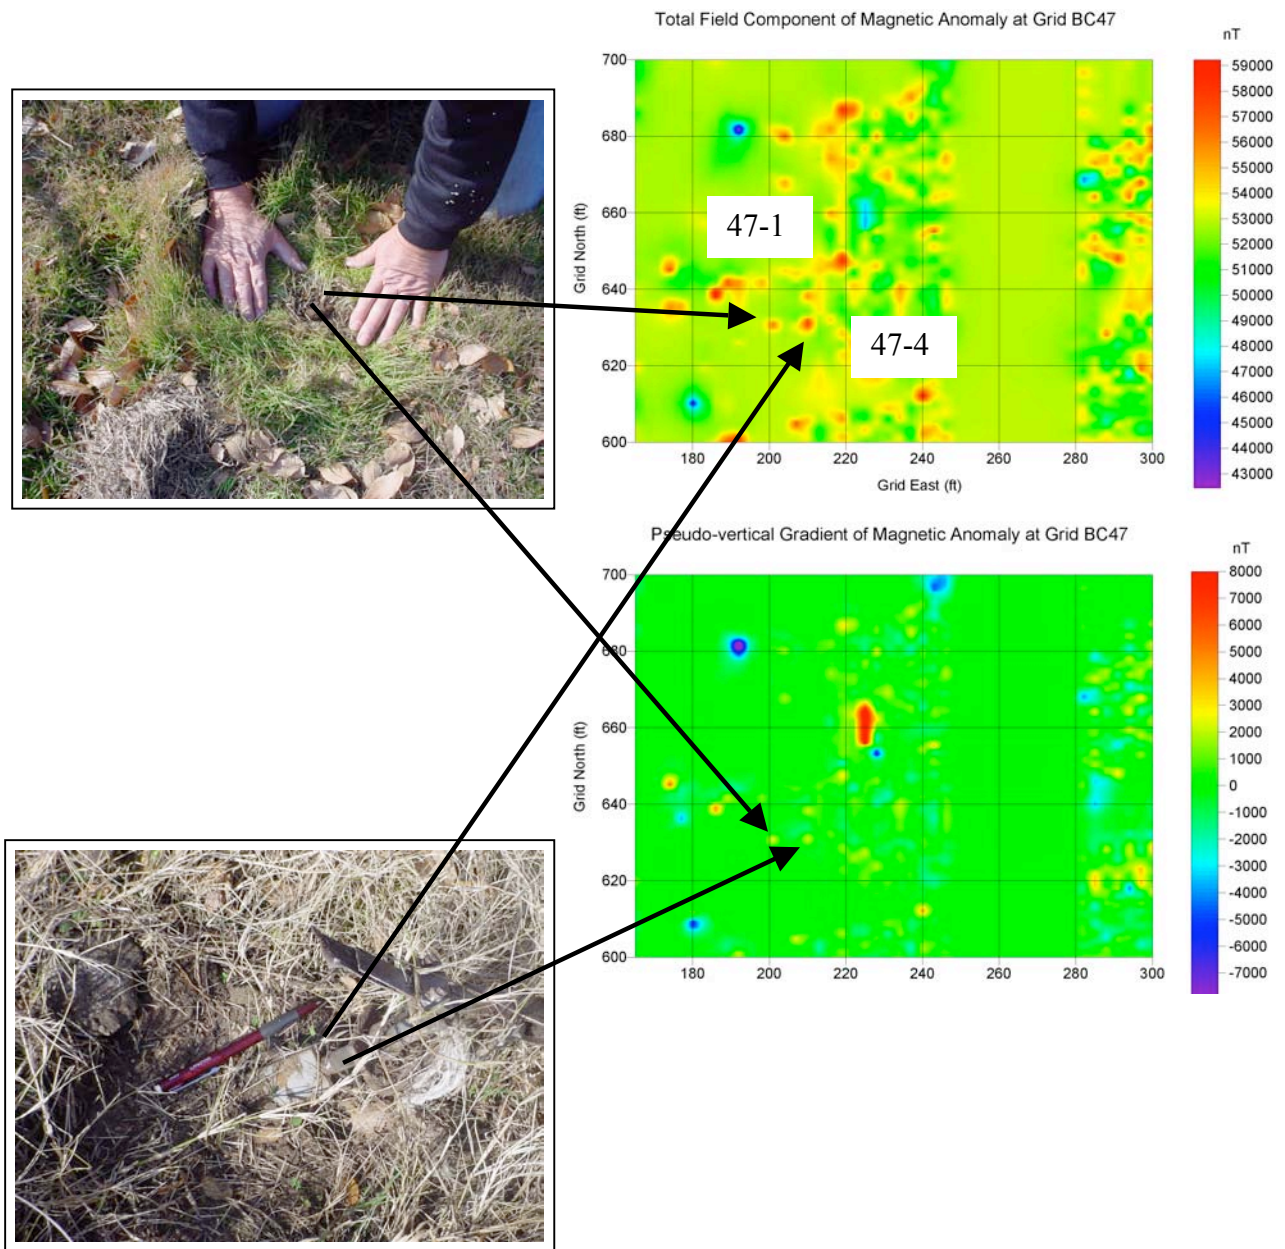
Figure 15a. Two tie-downs for a trailer at (201, 631) and (210, 631) in Grid 47 produced anomalies with amplitude of around 3,000 nT with the half-width of 2 ft or less (right). Similar anomalies can also be seen at (176, 646) and (186, 639), and (240, 612), etc.

C. Trailer ties								
	44	2	445	1073	58,200	1.5	180a tie-down for a trailer	2061
	47	3	201	631	56,230	2	130a tie-down for a trailer	2066
	47	4	210	631	57,840	2	130a tie-down for a trailer	2067
	48	2	210	590	58,230	2	190a trailer tie	2070
	48	3	190	598	58,070	3	100a trailer tie	2071

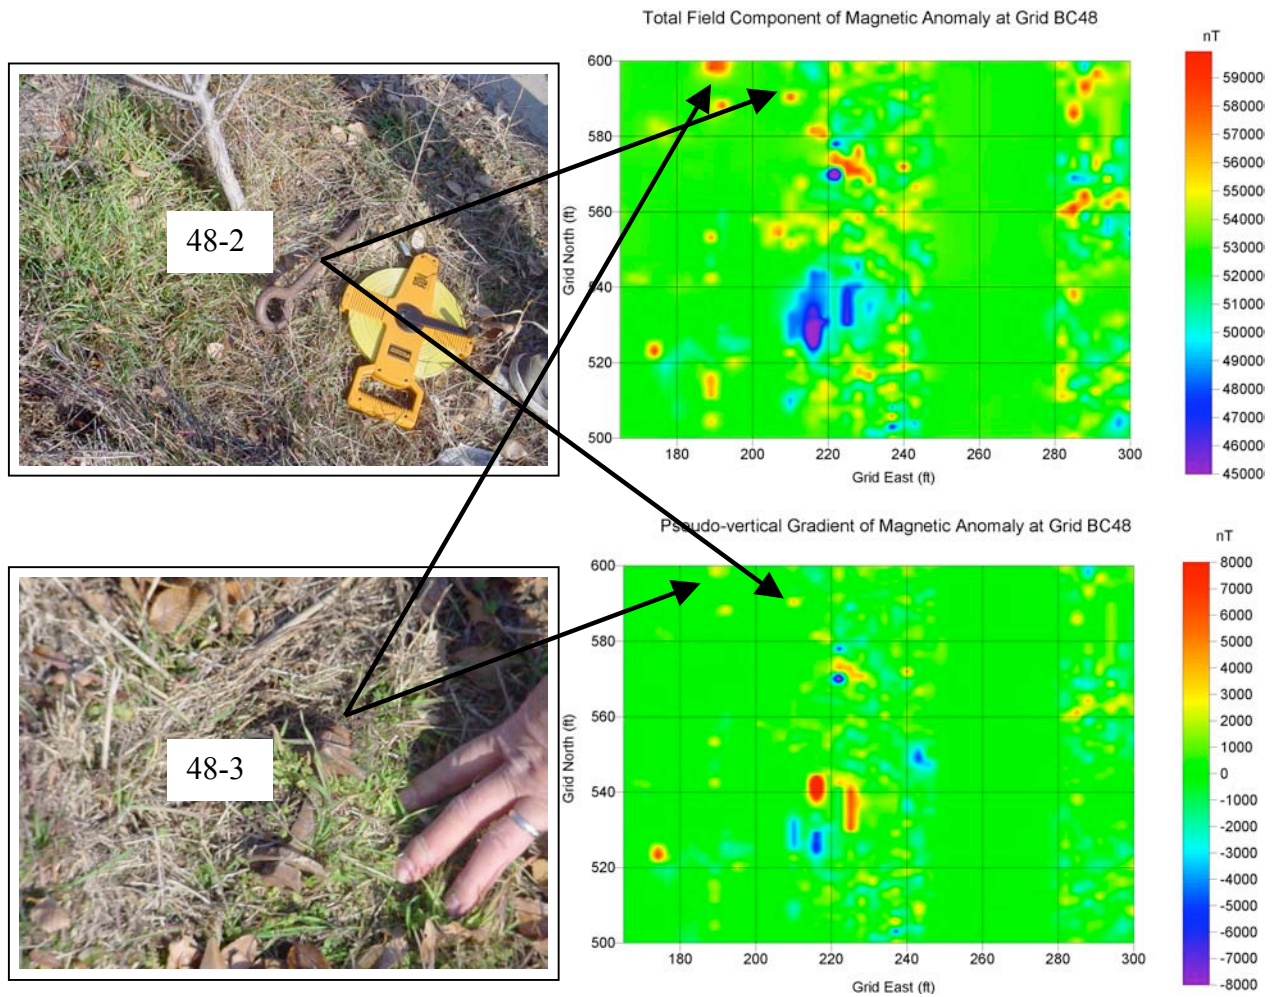
Figure 15b. Two tie-downs for a trailer at (210, 590) and (190, 598) in Grid 48 produced anomalies with amplitude of around 4,000 nT with the half-width of 3 ft or less (right). Similar anomalies can also be seen at (176, 522), etc.

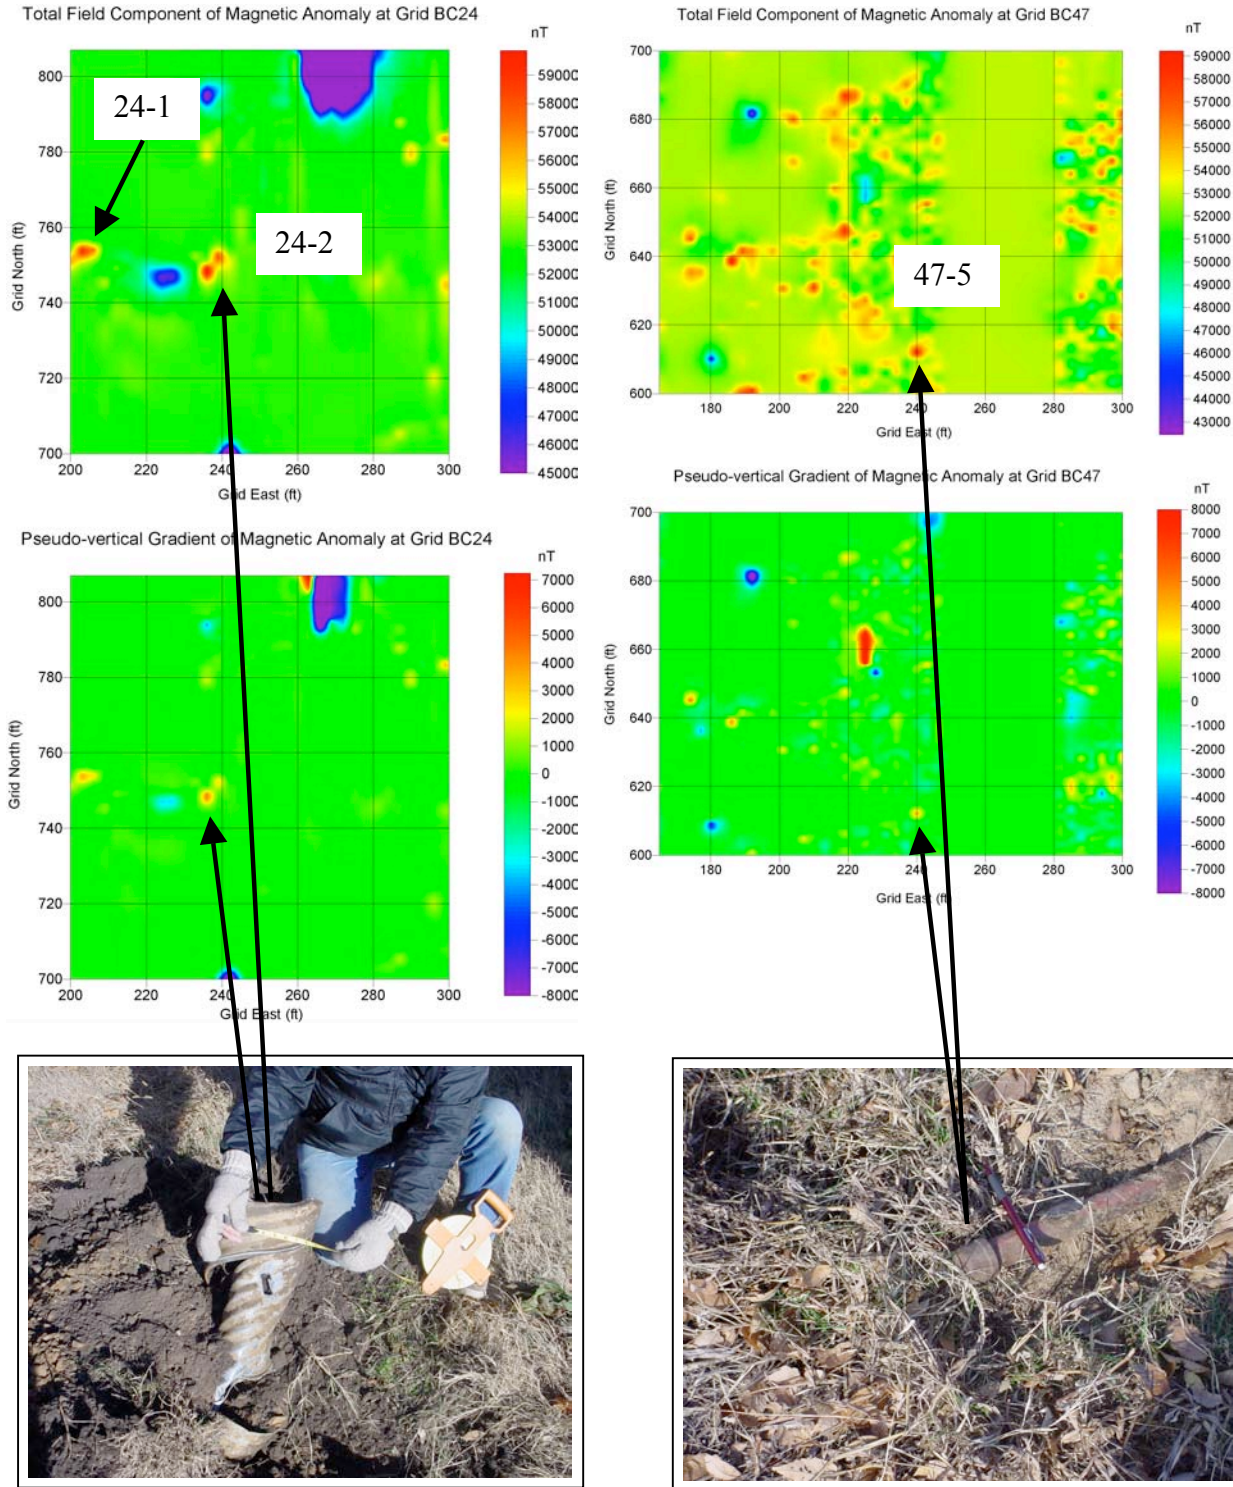
Figure 18. A 6" horizontal corrugated drainage pipe (236, 748) in Grid 24 at a depth of 1 ft. The total field component of the magnetic anomaly and gradient data. The anomaly was on the one side of a street. The almost same anomaly (BC24-1) at the other side of the street (203, 752) and was interpreted as the other end of the drainage pipe. The other anomaly due to the end of horizontal pipe was located at (240, 612) in Grid 47.

F. Horizontal pipes									
24	1	204	754	58,120	2	150	the other end of 6" corrugated drainage pipe (no digging)		
24	2	236	748	59,860	2	210a	horizontal 6" corrugated drainage pipe, 1 ft deep		2081
47	5	240	612	59,160	2	230a	1" (an end of horizontal) pipe		2068

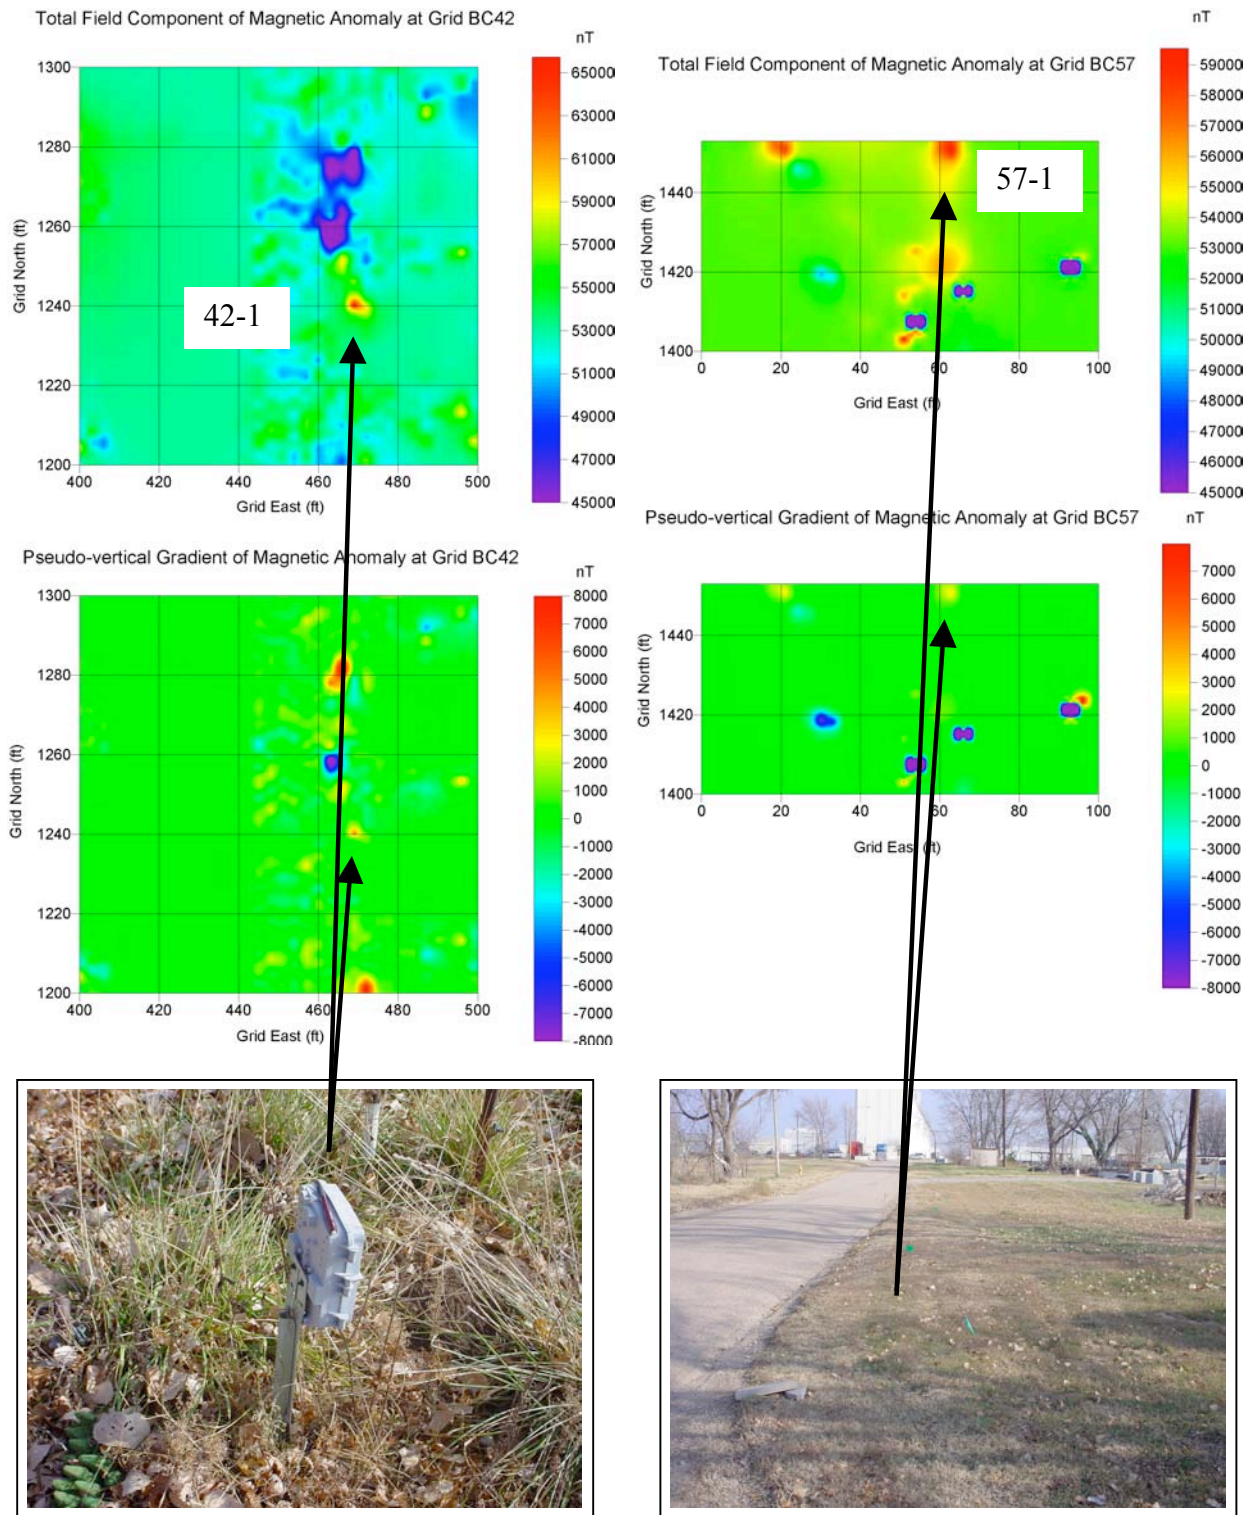
Figure 19. A telephone box produced a magnetic anomaly with amplitude of 12,000 nT and gradient of 300 nT/in at (469, 1240) in Grid 42. An anomaly at (63, 1451) in Grid 63 was interpreted to be due to a sewer line. The other anomaly at (20, 1452) in Grid 63 was also interpreted to be due to the same sewer line.

G. Other sources									
13	1	115	839	58,480	1.5	170a	2' sawer cover		2048
17	1	145	1061	59,750	2	210	2 T-shape posts (steel), 3' apart		2050
29	1	315	908	59,630	3	130a	small shed (corrugated metal sheet)		2053
36	1	272	1364	64,960	5.5	300a	pile of junk metal sheets		2057
42	1	469	1240	65,730	3	250a	telephone box		2059
44	3	460	1077	62,480	2	380a	corner of a shed		2062
48	1	192	588	58,350	2	180	steel cables		2069
55	2	460	200	58,860	2	200a	water meter		2074
57	1	63	1451	59,510	2.5	140a	sewer line (Green flags)		2076
