Kansas Geological Survey

GROUND WATER ASSESSMENT IN ASSOCIATION WITH SALT CEDAR CONTROL – REPORT ON YEAR ONE ACTIVITIES

Kansas Geological Survey Open-File Report 2005-19
July 2005

**Project: Ground Water Assessment in Association with Salt Cedar Control
Duration: August 16, 2004 to June 30, 2005**

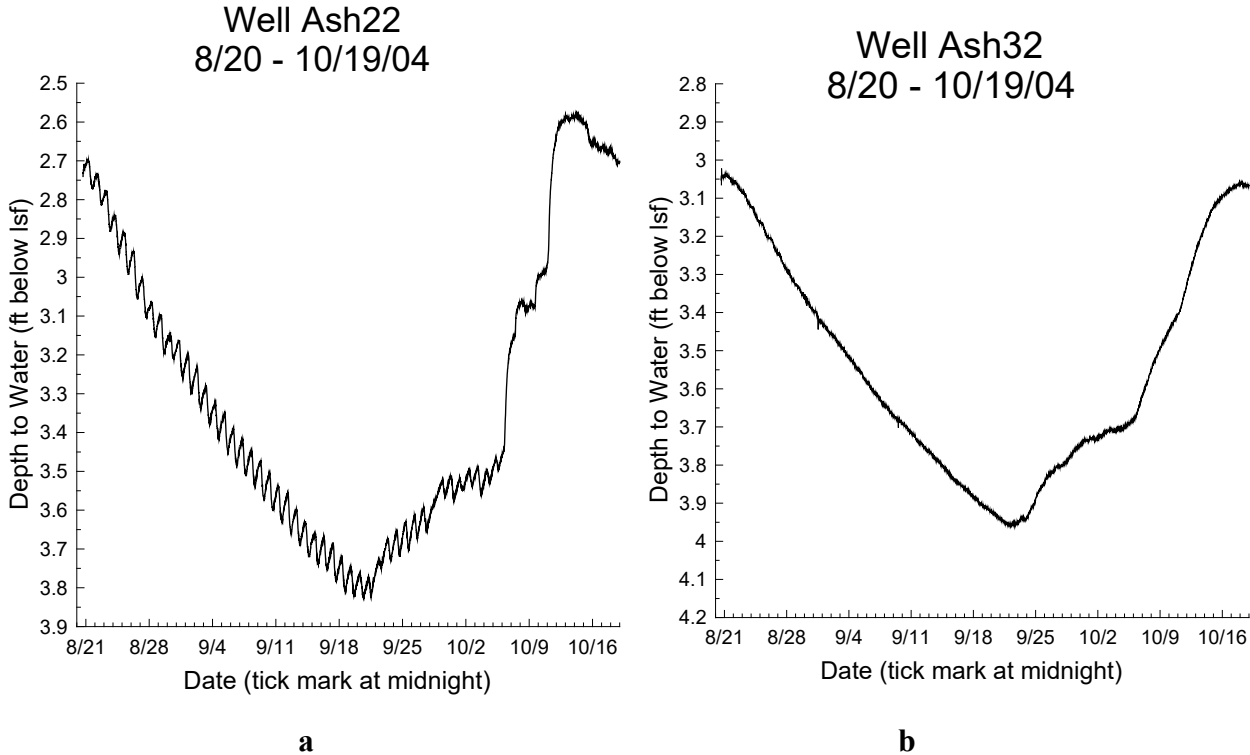
Figure 3 - Depth to water recorded in two wells at the Ashland Research Site prior to application of salt-cedar control measures. Well Ash22 (a) is located in an area of vigorous salt cedar growth, while well Ash32 (b) is located in an area of stunted salt cedar. Note that the length of the interval represented by the y-axis is the same for both plots.

In the reporting period for this contract, six wells equipped with submersible pressure sensors were installed in Plots 1-3 in order to monitor water-table responses in the vicinity of the most common phreatophyte communities at the site (wells were not placed in Plot 4 because of concerns about possible well damage from the planned burning). A neutron-probe access tube was emplaced adjacent to each well so that water content in the vadose zone (interval between the water table and the land surface) could also be measured. A weather station was installed on the north end of Plot 3 to monitor meteorological conditions and provide estimates of the potential for evapotranspiration. Water-level data collected in the late summer and early fall of 2004, prior to any control activities and prior to salt-cedar dormancy, clearly demonstrate that the magnitude of the diurnal water-table fluctuations observed at a well is highly dependent on the apparent vitality of the phreatophyte community in the vicinity of that well (Figures 3a-b). Thus, the initial data indicate that the strategy of using water-table fluctuations to assess ground-water savings gained from control activities appears to have considerable potential at this site.

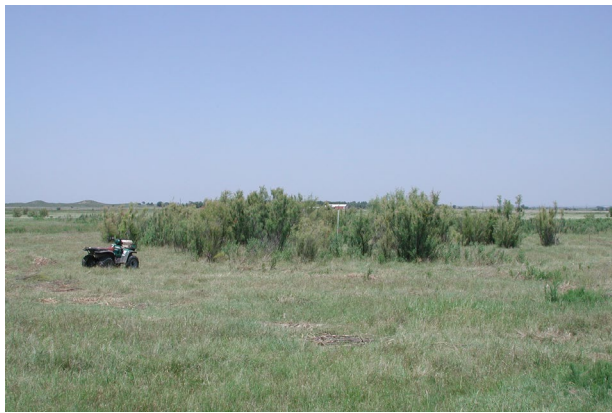
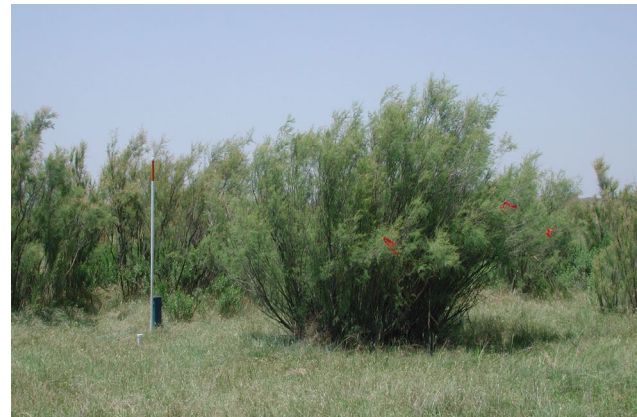
Figure 4 – a) Aerial photo of Ashland Research Site with boundaries of vegetation circles remaining after mid-March 2005 and June 3, 2005, cuttings (circle boundaries recorded with handheld GPS unit; vegetation completely cleared around well Ash32 on June 3); b) Photo (6/16/05) of vegetation circle around well Ash22 following June 3rd cutting (view looking north, ATV on left for scale, pole visible at center of plot is 8.5 ft in height; note remnants of cut salt cedar in foreground); c) Photo (6/16/05) of large salt cedar that will remain as the single plant near well Ash22 (red tape used to indicate plants that should remain following next cutting to reduce the circle to 22 ft in radius).

Application of salt-cedar control measures began in March 2005 (Figures 4a-c). At that time, plots 2-4 were clear cut except for circles ranging from 70-100 ft in radius about the four

monitoring wells in Plots 2 and 3. The radii of those circles of vegetation were reduced to 45 ft at three of the four wells on June 3, 2005. The vegetation was completely cleared about well Ash32 on June 3 because of the lack of any plant-induced water-table responses at that well since the start of monitoring in August 2004 (Figure 3b). The circles at the other three wells in Plots 2 and 3 were reduced to 22 ft on June 27, 2005. Two weeks later, all plants except one will be cut in the three remaining circles. In approximately another two weeks, the final plant in each plot will be removed. After the control measures have been fully applied, water-level data from the treated plots will be compared to data from the untreated area (Plot 1). That comparison should enable quantification of reductions in ground-water consumption produced by those measures. Note that a number of tasks not funded by this contract were also performed by the KGS/KSU research team in order to increase the value of the project results. For example, data on vegetation within the experimental plots were not obtained as originally planned by cooperators on the KAWS project. Thus, the research team decided to collect vegetation data on its own as the circles about the wells were reduced below 45 ft in radius. That vegetation inventory is ongoing so the results will be presented in a subsequent project report.

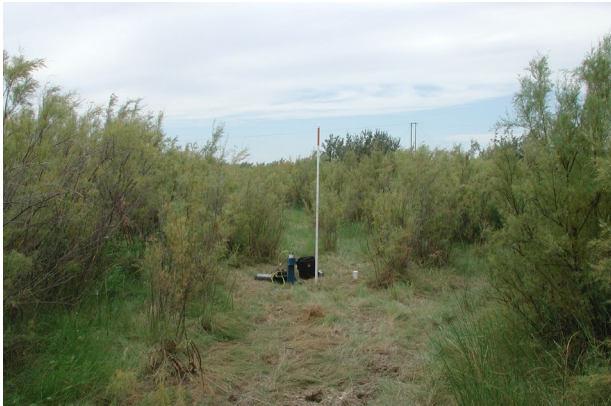
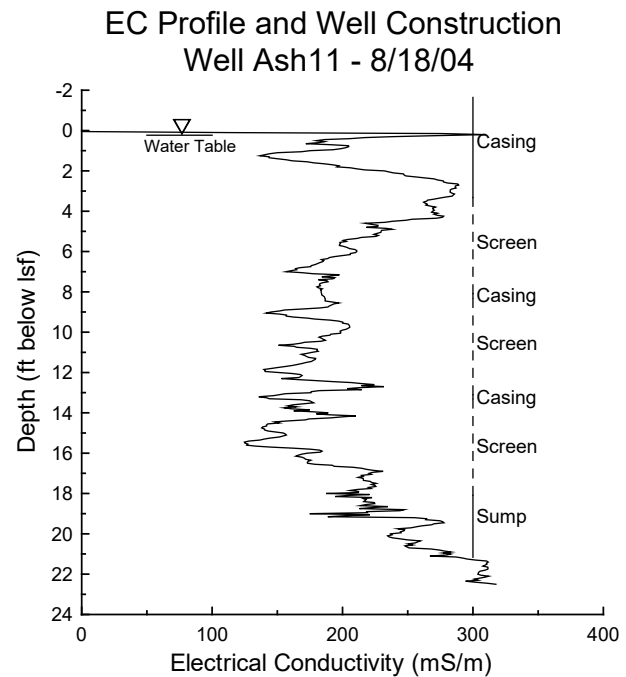
This well site is located near the south edge of Plot 1 in a low-lying area of dense salt cedar near the Cimarron River (Figure 5a). The water table was within 0.3 ft of the land surface at the time of installation and remained close to the surface for most of the monitoring period due to the proximity of the Cimarron River. Figure 5b displays the EC log obtained at the site and relevant well-completion information. The well is screened from 3.3-18.1 ft below lsf. It appears that the top of the screen is in a zone with some clay. The interval from 6-16 ft, however, appears to have little clay and is thought to consist primarily of sand. The relatively high EC (for sand) values in that interval are a product of the high specific conductance of the ground water (sample collected 8/18/04: 10,000 $\mu\text{S}/\text{cm}$ at 25 deg C = 1,000 mS/m in units of EC log) with very little matrix contribution.

Figure 5 – Photograph (a) and EC log (b) for Ash11 well site (see Table 1 for further well information; photograph taken on 8/31/04).

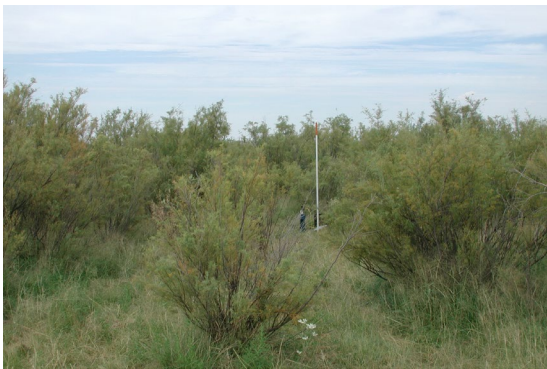
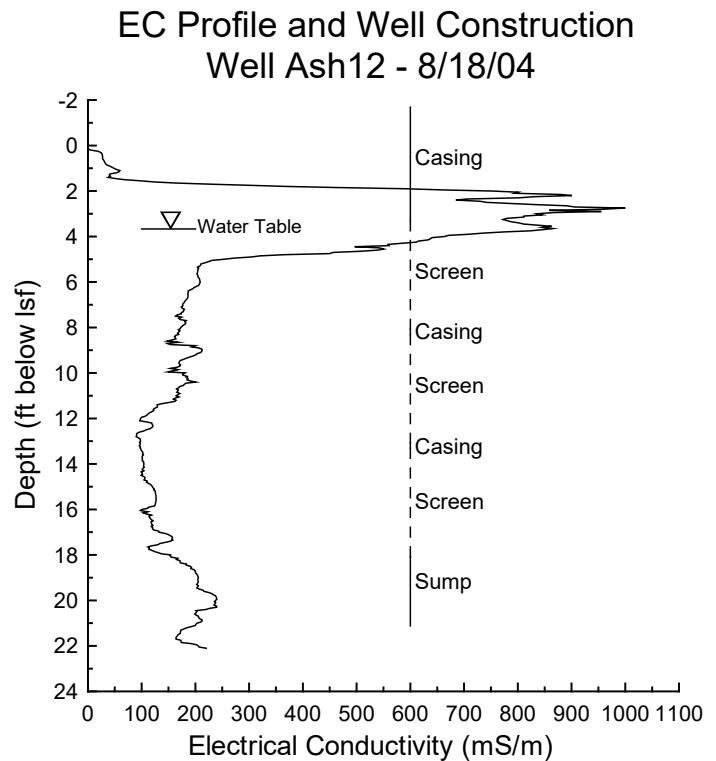
This well site is located near the center of Plot 1 on a terrace above the Cimarron River in the densest growth of salt cedar observed on the site (Figure 6a). The water table was 3.7 ft from the land surface at the time of installation. Figure 6b displays the EC log obtained at the site and relevant well-completion information. The well was screened from 3.3-18.1 ft below lsf. It appears that the top of the screen is in the lower portions of a clay-rich zone that extends from 1.5-5 ft below lsf. The interval from 6-11 ft is characterized by an approximately constant EC and is thought to consist primarily of sand with small amounts of fine material. The relatively high (for sands) EC values in that interval are primarily a product of the high specific conductance of the ground water (sample collected 8/18/04: $7,740 \mu\text{S}/\text{cm}$ at $25 \text{ deg } C = 774 \text{ mS}/\text{m}$ in units of EC log). Later specific conductance profiling found that the drop in EC at about 11 ft is not caused by a change in fluid EC. The most likely cause of that drop is a decrease in porosity and/or clay content.

Figure 6 – Photograph (a) and EC log (b) for Ash12 well site (see Table 1 for further well information; photograph taken on 8/31/04).

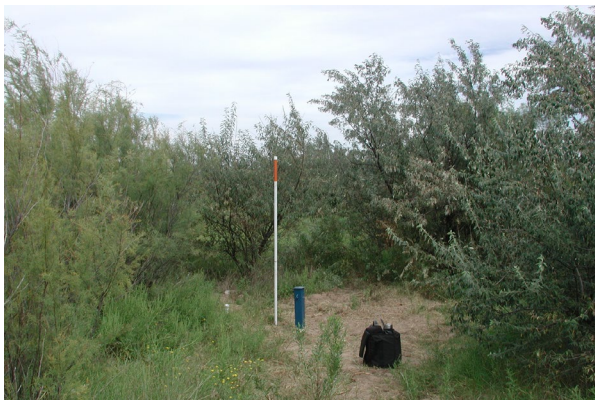
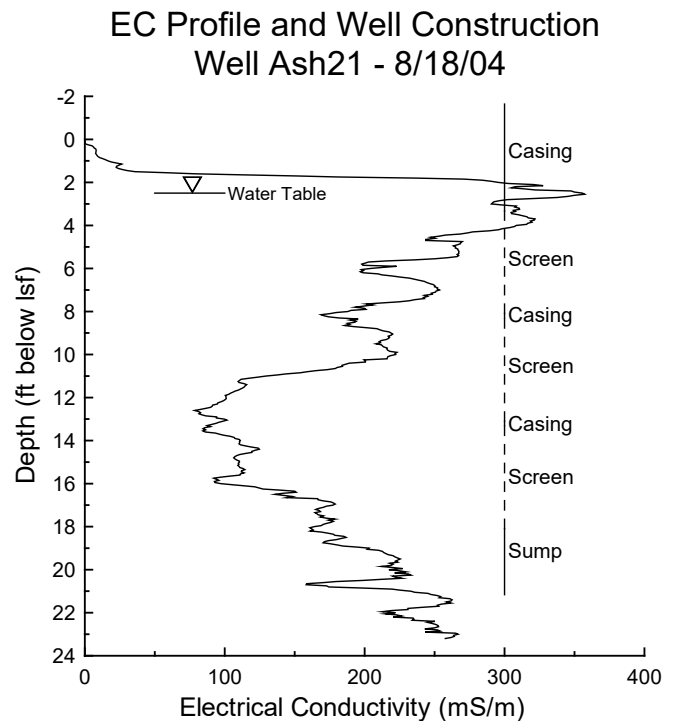
This well site is located near the southern boundary of Plot 2 on the first terrace above the Cimarron River. The well is in an area of salt cedar and Russian olive (Figure 7a) that occur in a thin band across the southern portions of Plot 2; the Russian olive at the back right of the clearing in Figure 7a was one of the largest trees found on the four plots. The water table was 2.4 ft from the land surface at the time of installation. Figure 7b displays the EC log obtained at the site and relevant well-completion information. The well was screened from 3.3-18.1 ft below lsf. It appears that the top of the screen is in a zone with some clay that extends from 1.5-4.5 ft below lsf. The interval from 5.5-10 ft is thought to be sand. The relatively high (for sands) EC values in that interval are primarily a product of the high specific conductance of the ground water (sample collected 8/19/04: $8,890 \mu\text{S}/\text{cm}$ at $25 \text{ deg C} = 889 \text{ mS}/\text{m}$ in units of EC log) with minor matrix contribution. Later specific conductance profiling found that the lower EC values from 11-16 ft are not caused by a change in fluid EC. The most likely causes of that drop are a decrease in porosity and/or clay content similar to that suspected at well Ash12. Similarly, the increase in EC from 16-18 ft is not caused by a change in fluid EC and is most likely a result of an increase in porosity and/or clay content.

Figure 7 – Photograph (a) and EC log (b) for Ash21 well site (see Table 1 for further well information; photograph taken on 8/31/04).

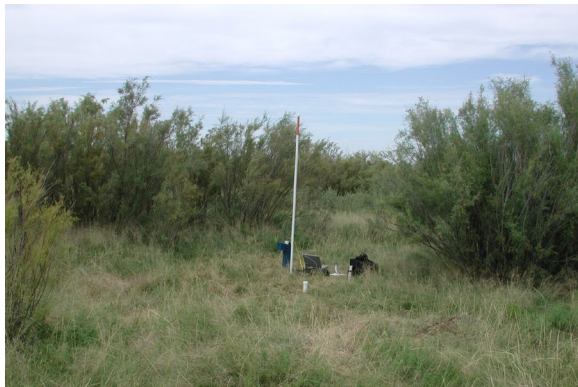
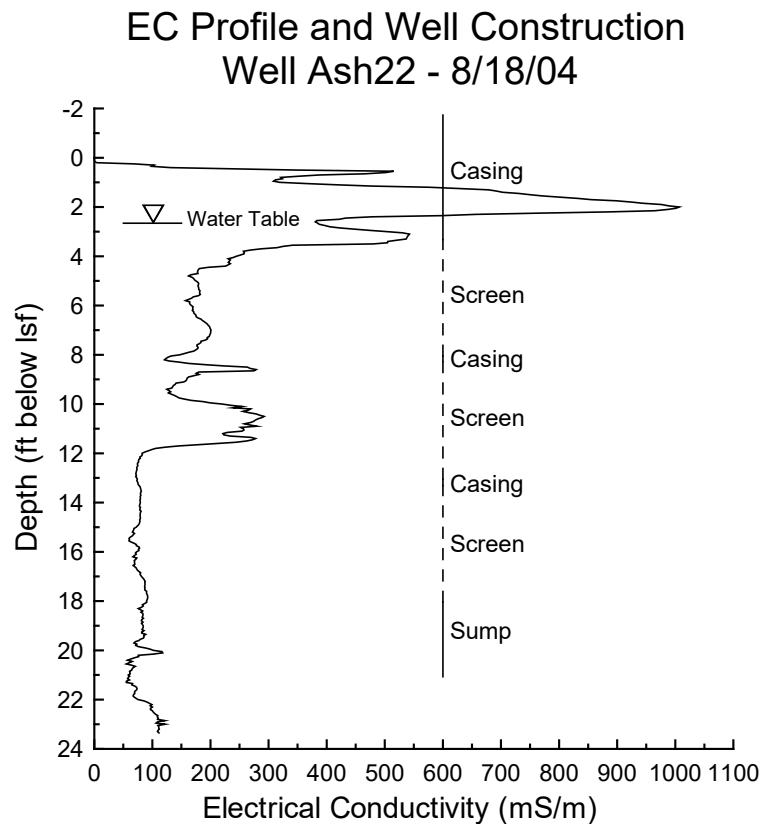
This well site is located in the northern half of Plot 2 in an area of large thriving clumps of salt cedar (Figure 8a). These salt cedar are the largest and healthiest looking in the four plots. The water table was 2.7 ft from the land surface at the time of installation. Figure 8b displays the EC log obtained at the site and relevant well-completion information. The well was screened from 3.3-18.0 ft below lsf. There are three distinct segments to the EC log. The top of the screen appears to be in a zone of high EC that extends from 0.5-4 ft below lsf. The interval from 4-11.5 ft is characterized by relatively constant EC and is thought to consist primarily of sand with some clay. The relatively high (for sands) EC values in that interval are a product of the high specific conductance of the ground water (sample collected 8/19/04: 5,100 $\mu\text{S}/\text{cm}$ at 25 deg C = 510 mS/m in units of EC log) with additional matrix contribution. Specific conductance profiling found that the lower EC values below 11.5 ft are not caused by a change in fluid EC. The most likely cause of that drop is a decrease in porosity and/or clay content similar to that suspected at wells Ash12 and Ash21.

Figure 8 – Photograph (a) and EC log (b) for Ash22 well site (see Table 1 for further well information; photograph taken on 8/31/04).

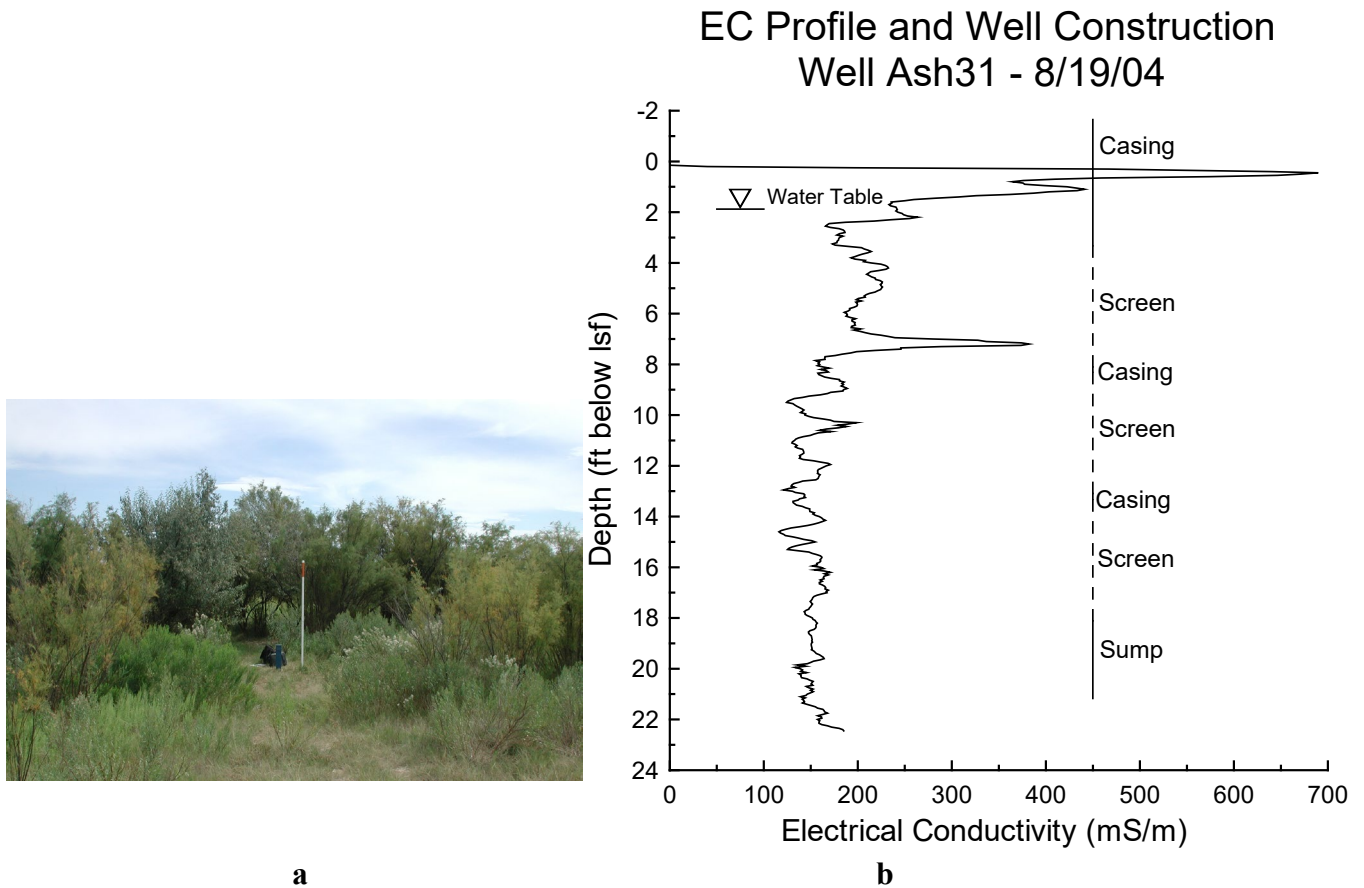
This well site is located in a low-lying area in the southern half of Plot 3. The site is in a thin band of salt cedar and Russian olive (similar to well Ash21) that extends across Plot 3 (Figure 9a). The water table was 1.9 ft from the land surface at the time of installation. Figure 9b displays the EC log obtained at the site and relevant well-completion information. The well was screened from 3.3-18.1 ft below lsf. There are three distinct segments on the EC log. There is a zone of high EC that extends from the surface to about 1.5 ft below lsf. The top of the screen is in an interval that extends 2-7.5 ft below lsf that is characterized by a relatively constant EC and is thought to consist primarily of sand with some finer material. The relatively high (for sands) EC values in that interval are a product of the high specific conductance of the ground water (sample collected 8/19/04: 7,000 $\mu\text{S}/\text{cm}$ at 25 deg C = 700 mS/m in units of EC log) with some matrix contribution. Specific conductance profiling found that the lower EC values below 7.5 ft are not caused by a change in fluid EC. The most likely cause of that drop is a decrease in porosity and/or clay content similar to that suspected at wells Ash12, Ash21, and Ash22. The EC decrease, however, is smaller than that observed at the other wells.

Figure 9 – Photograph (a) and EC log (b) for Ash31 well site (see Table 1 for further well information; photograph taken on 8/31/04).

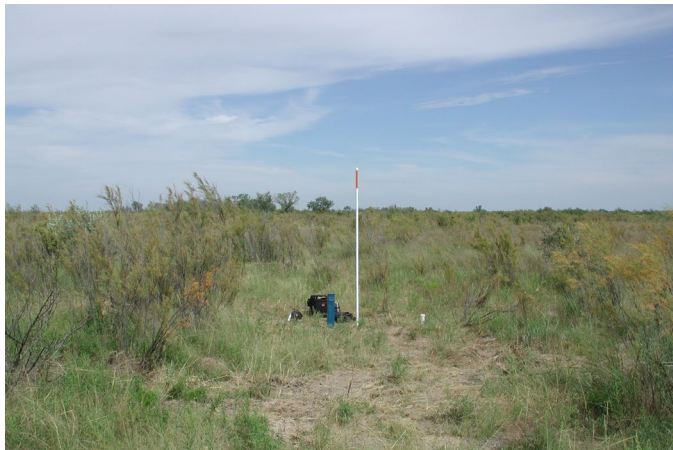
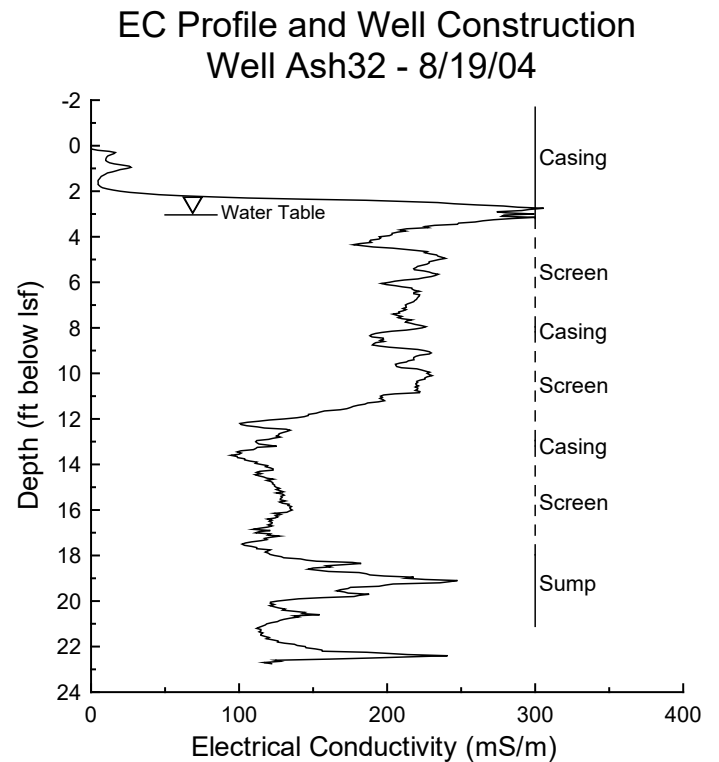
This well site is located in the middle of Plot 3 in a zone of diminutive and sickly looking salt cedar that stretches across all four plots (Figure 10a). The water table was 3.0 ft from the land surface at the time of installation. Figure 10b displays the EC log obtained at the site and relevant well-completion information. The well was screened from 3.2-18.0 ft below lsf. There are four distinct segments on the EC log. A zone of very low EC, most likely indicative of dry sand, extends from the surface to a depth of 2 ft. A zone of higher EC caused by salt accumulation and/or a higher clay content extends from 2 to 3.5 ft below lsf with the top of the screen near the bottom of that zone. A zone of relatively constant EC extends from 3.5 to 11 ft below lsf and is thought to consist primarily of sand with lesser amounts of clay. The relatively high (for sands) EC values in that interval are a product of the high specific conductance of the ground water (sample collected 8/19/04: 8,260 $\mu\text{S}/\text{cm}$ at 25 deg C = 826 mS/m in units of EC log) with some matrix contribution. A zone of lower EC extends to the bottom of the screen. Specific conductance profiling found that the lower EC values below 11 ft are not caused by a change in fluid EC. The most likely cause of that drop is a decrease in porosity and/or clay content similar to that suspected at all the other wells except Ash11.

Figure 10 – Photograph (a) and EC log (b) for Ash32 well site (see Table 1 for further well information; photograph taken on 8/31/04).

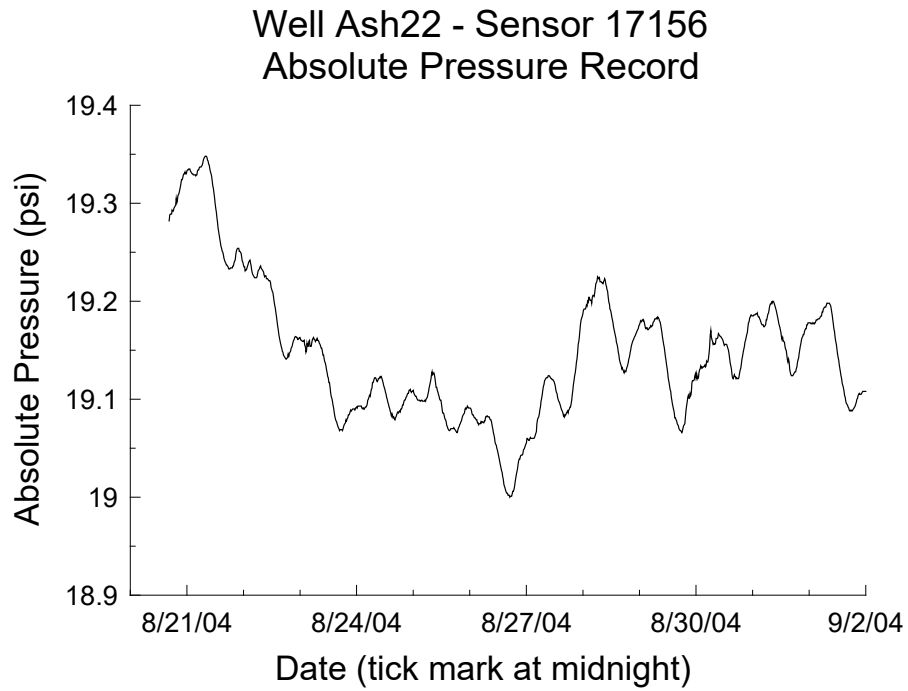
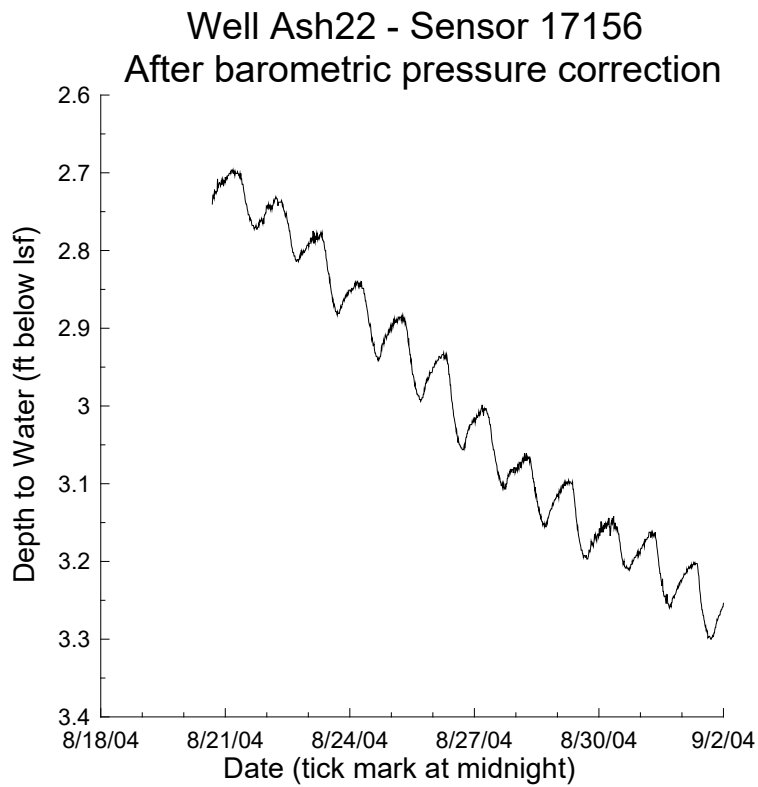
Figure 11 - a) Absolute-pressure record from sensor (17156) in the water column in Ash22; b) Depth to water at well Ash22 calculated after atmospheric-pressure component is removed from Ash22 sensor using barometer (sensor 16977) in air column at well Ash12.

All wells except Ash11 have an integrated pressure-transducer and datalogger unit submerged in the water column (30 psi absolute-pressure miniTroll, In-Situ, Inc.). This unit measures and records the pressure exerted by the overlying column of water and the atmosphere. Ash11 has a more sophisticated sensor (Troll 9000, In-Situ, Inc.) that measures the specific conductance and temperature of the ground water, as well as the pressure exerted by the overlying column of water and the atmosphere. Pressure readings are taken every 15 minutes in all wells and checked periodically with manual depth-to-water measurements (biweekly during the summer months and bimonthly otherwise). The temperature and specific conductance of the ground water at well Ash11 are measured at that same 15-minute interval and sensor operation is checked periodically using a hand-held specific-conductance and temperature meter (Model 30 Conductivity and Temperature Probe, YSI). As of the end of this reporting period, all sensors appeared to be performing well.

Absolute-pressure sensors were used in the wells instead of gage-pressure sensors in order to prevent sensor damage (via water movement down the vent tube of a gauge-pressure sensor) in the case a well is overtopped during high river stages. The Cimarron River overtopped Ash11 at least twice during this reporting period and reached the base of well Ash31 on at least one occasion (observations by the research team and Dave Arnold), demonstrating the need for absolute-pressure sensors in those wells. In order to compute the height of the overlying column of water (and thus the position of the water table) from the absolute-pressure measurement, the atmospheric-pressure component of that measurement must be removed. Atmospheric pressure is measured at the same 15-minute interval using two on-site barometers (baroTroll, In-Situ, Inc.) placed in the air column above the water table in wells Ash12 and Ash32. Figures 11a-b display records from the sensor in well Ash22 prior to and after the barometric pressure correction, respectively. Because of unanticipated problems with the barometers at wells Ash12 and Ash32 discussed in a later section, an additional barometer was placed in the weather station near the end of the reporting period.

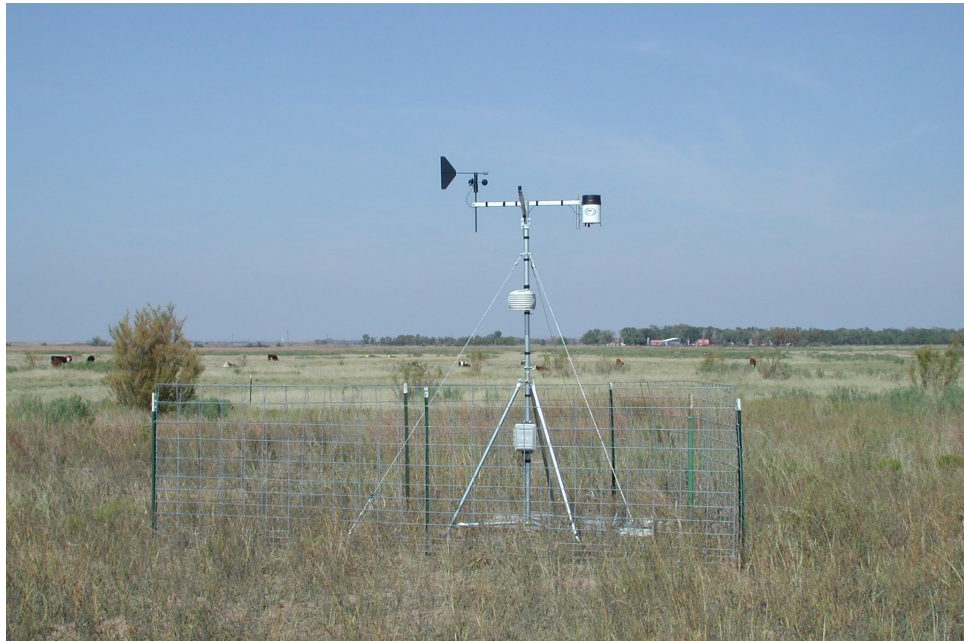
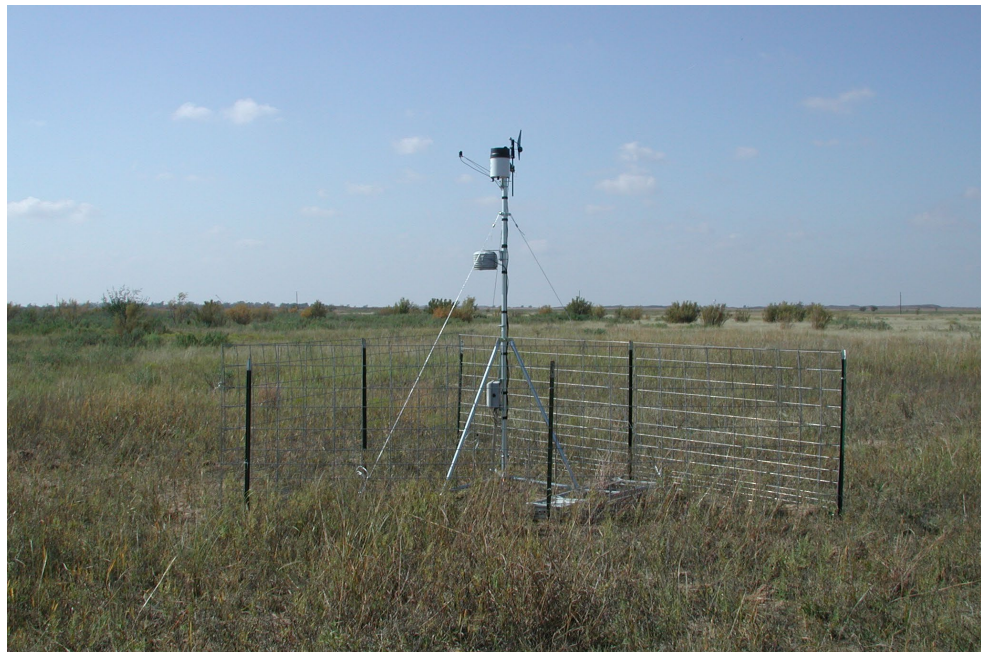
Figure 12 – Weather station at Ashland viewed from the south (a) and east (b). Tipping-bucket rain gage is on the right end of cross bar in photograph (a), while wind-speed and direction sensors are on left end of same cross bar. Solar radiation sensor (pyranometer) is on slanted arm extending outward to the south (left) near top of weather station in photograph (b). Relative humidity and temperature sensors are in radiation shield at an elevation of two meters above lsf. Barometer is inside datalogger housing located on main pole below point where support legs connect to main pole. Dave Arnold home is in the distance in the center right of photograph (a).

A weather station (Hobo Weather Station, Onset Computing Corp.) that measures and records a suite of meteorological data (air temperature, precipitation, relative humidity, solar radiation, and wind speed and direction) was installed on high ground in the northern portion of Plot 3 (Figures 2 and 12) on October 19, 2004. On June 2, 2005, a barometer was added to the weather station. Data are collected at 15-minute intervals and are the ending values (air temperature, relative humidity, solar radiation, and barometric pressure), averages (wind speed and direction), or summation (precipitation) for that 15-minute interval.

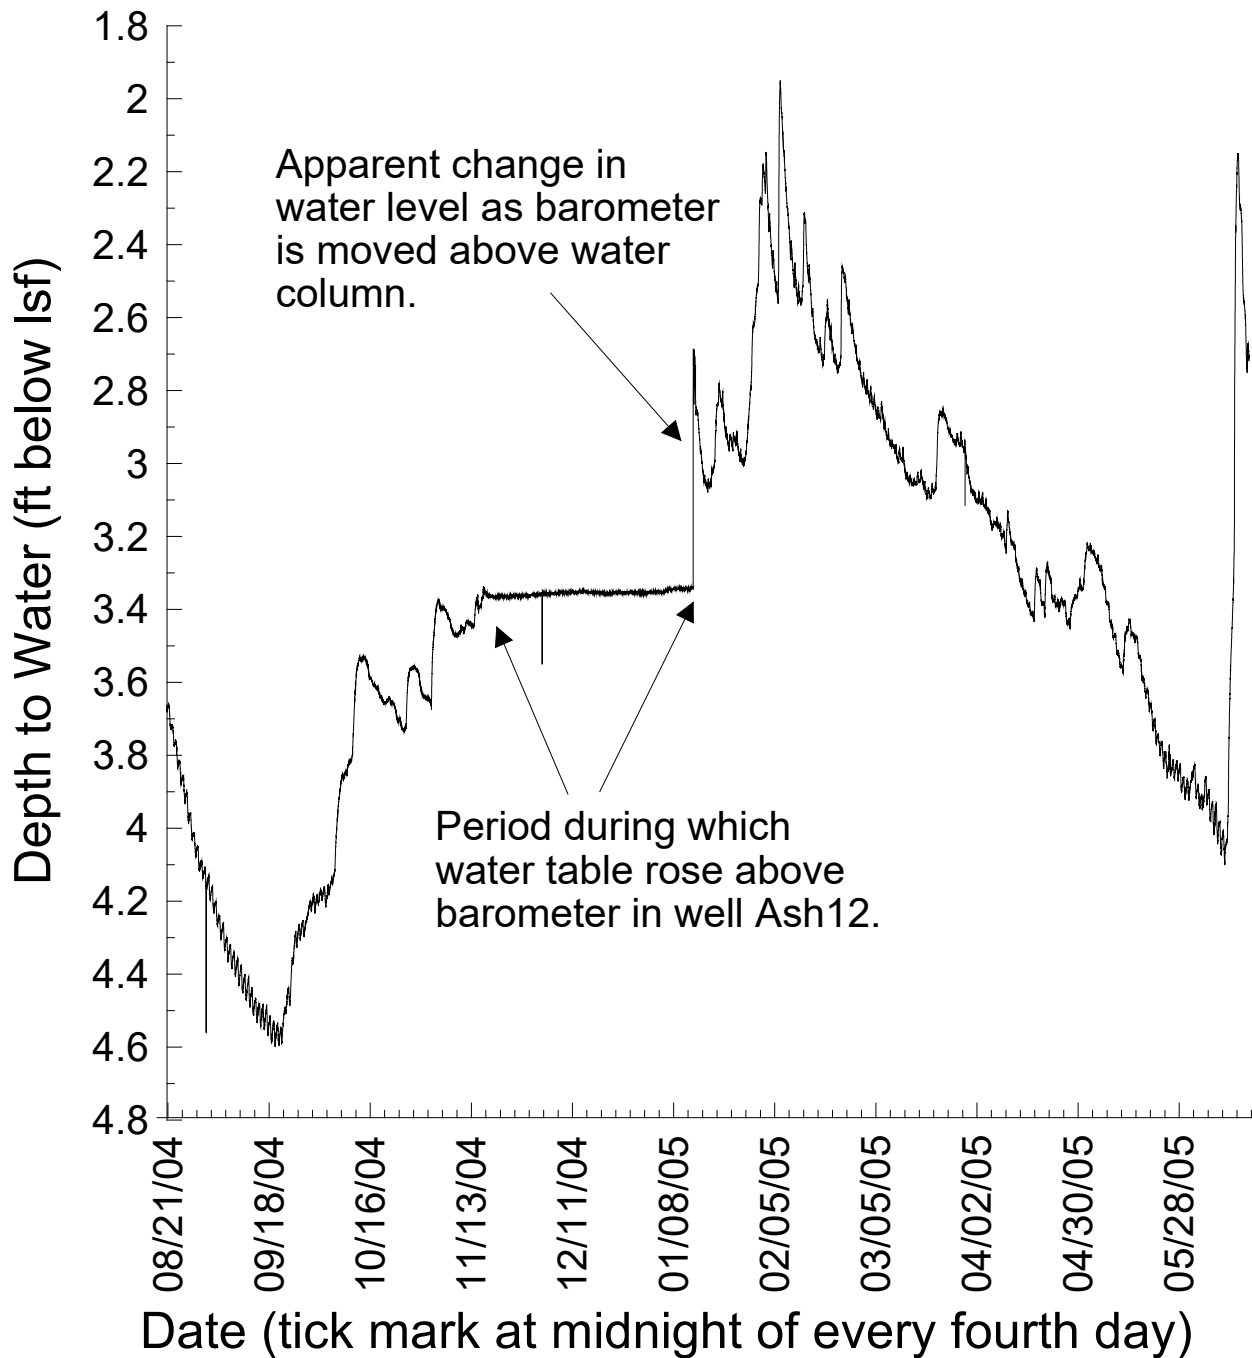
Well Ash12 - Sensor 15936

Figure 13 - Depth to water from land surface recorded in well Ash12 for the entire reporting period (well Ash12 in unaltered area [Plot 1], Figure 6a is a photograph of well and surrounding vegetation). Note high-frequency noise during winter months caused by incorrect temperature compensation of barometer readings.

Figures 13 and 14a-b are plots of depth to water recorded at well Ash12 for the entire reporting period, the first 60 days, and the last 60 days, respectively. The water table at well Ash12 varied over a 2.6-ft interval during the reporting period. At the start of the period in late August of 2004, plant-induced fluctuations in the water table were clearly observed (Figures 13 and 14a), as they were at well Ash22 (Figure 3a) and all other wells except well Ash32 (Figure 3b). These fluctuations die-out by mid-October as the salt cedar transition into dormancy and only reappear in May of 2005. Figures 13 and 14b illustrate the two problems that were encountered during the monitoring period. These problems, barometer submergence and incorrect temperature compensation of barometer measurements, are described in the following paragraphs.

Barometer submergence – The barometers were originally placed about 5 ft below the top of casing at wells Ash12 (3.35 ft below land surface) and Ash32. Unfortunately, the water table rose more than we anticipated. At 18:45 on 11/16/04, it rose above the sensing port for the barometer (sensor 16977) in well Ash12. The submergence of that barometer is easily recognized after processing the sensor in the water column at Ash12 (sensor 15936) because all pressure changes after submergence are the same for the original sensor in the water column and the now-submerged barometer. This situation creates a horizontal line on the water-level plot for well Ash12 (Figure 13). Note that the same problem occurred at well Ash32 on 19:30 on 10/13/04 but was not recognized due to the back-up status of that barometer. Because of a delay in processing the data downloaded on December 2, we did not recognize the problem until early January 2005. A KGS staff member went to the site and raised the barometers in both wells into the surface casing (barometers in both wells raised until sensing port was 0.08 ft above lsf) on 1/13/05. This was a foot higher than had been requested and led to a new problem discussed below. Although the submergence problem is now solved, there is no way of correcting the data between 11/16/04 and 1/13/05. Fortunately, the missing water-level data are of little importance to this project because there was essentially no transpiration during this period. Barometer submergence is now checked during each site visit and an additional back-up barometer has been added to the weather station.

Incorrect temperature compensation of barometer measurements - The repositioning of the barometers into the surface casing resulted in a new problem. As soon as the barometers were moved up, we saw additional noise in the data (Figures 13, 14b, and 15). We attributed that noise to incorrect temperature compensation of the barometric-pressure measurement. A temperature sensor inside the barometer body provides the reading used for the temperature compensation of the pressure measurement. We attribute the noise to the time required for that temperature sensor to equilibrate with the air temperature in the casing. Prior to equilibration, the barometric-pressure measurement is not thermally compensated in the appropriate manner, producing noise in the data record. The noise characteristically is observed as an abrupt upward spike coinciding with the onset of solar heating in the morning. The spike gradually decays during the day and virtually always disappears before midnight. This problem was resolved on May 25, 2005, when Dave Arnold, at our request, lowered the barometer in well Ash12 until its sensing port was at a position 1.59 ft below land surface. The temperature-induced fluctuations abruptly ceased at that time as shown by the pressure-sensor data from well Ash32 (Figure 15). On June 2, 2005, we moved the back-up barometer in well Ash32 to a sensing-port position of 1.56 ft below lsf. We are currently working on procedures to remove the noise produced by incorrect temperature

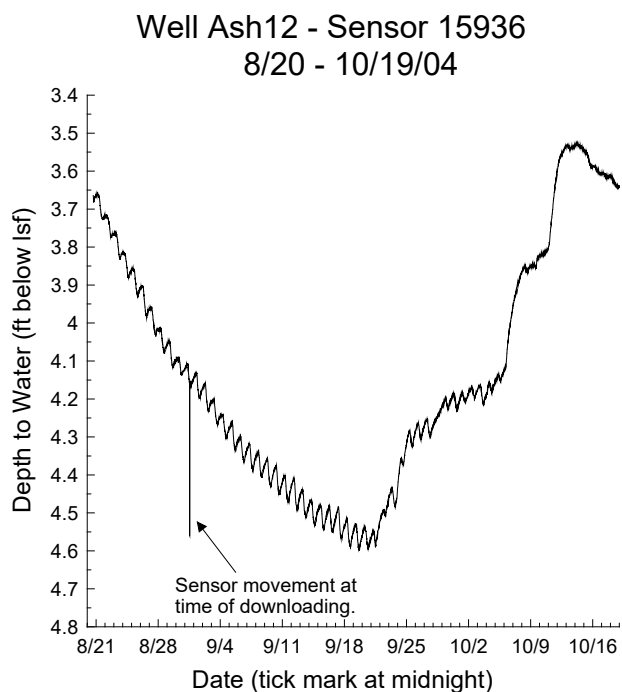
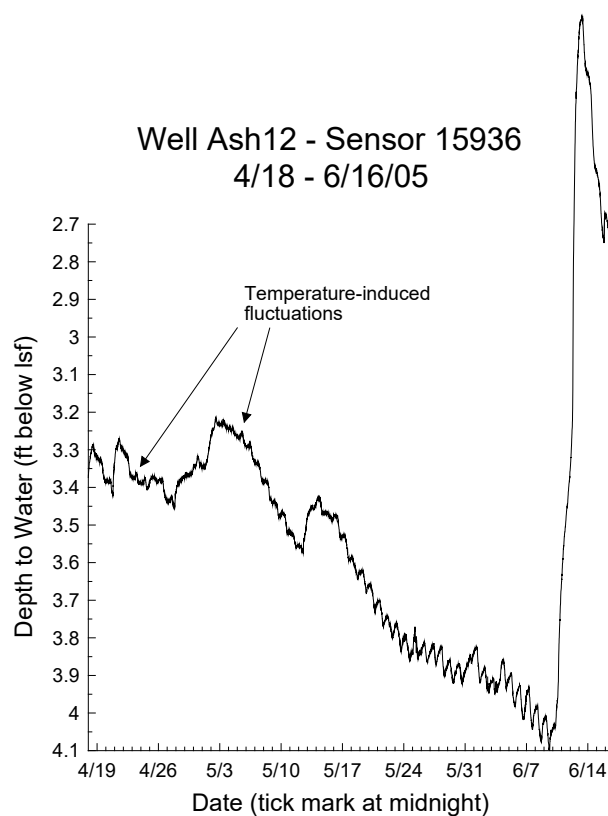
Figure 14 - Depth to water recorded in well Ash12 for the first (a) and final (b) 60 days of the reporting period (downward spikes in water-level data [a] are commonly observed at the time of downloading because the sensor is often moved up slightly to facilitate attachment of download cable; note vertical extent of y-axis in both plots is same as in Figure 3a-b).

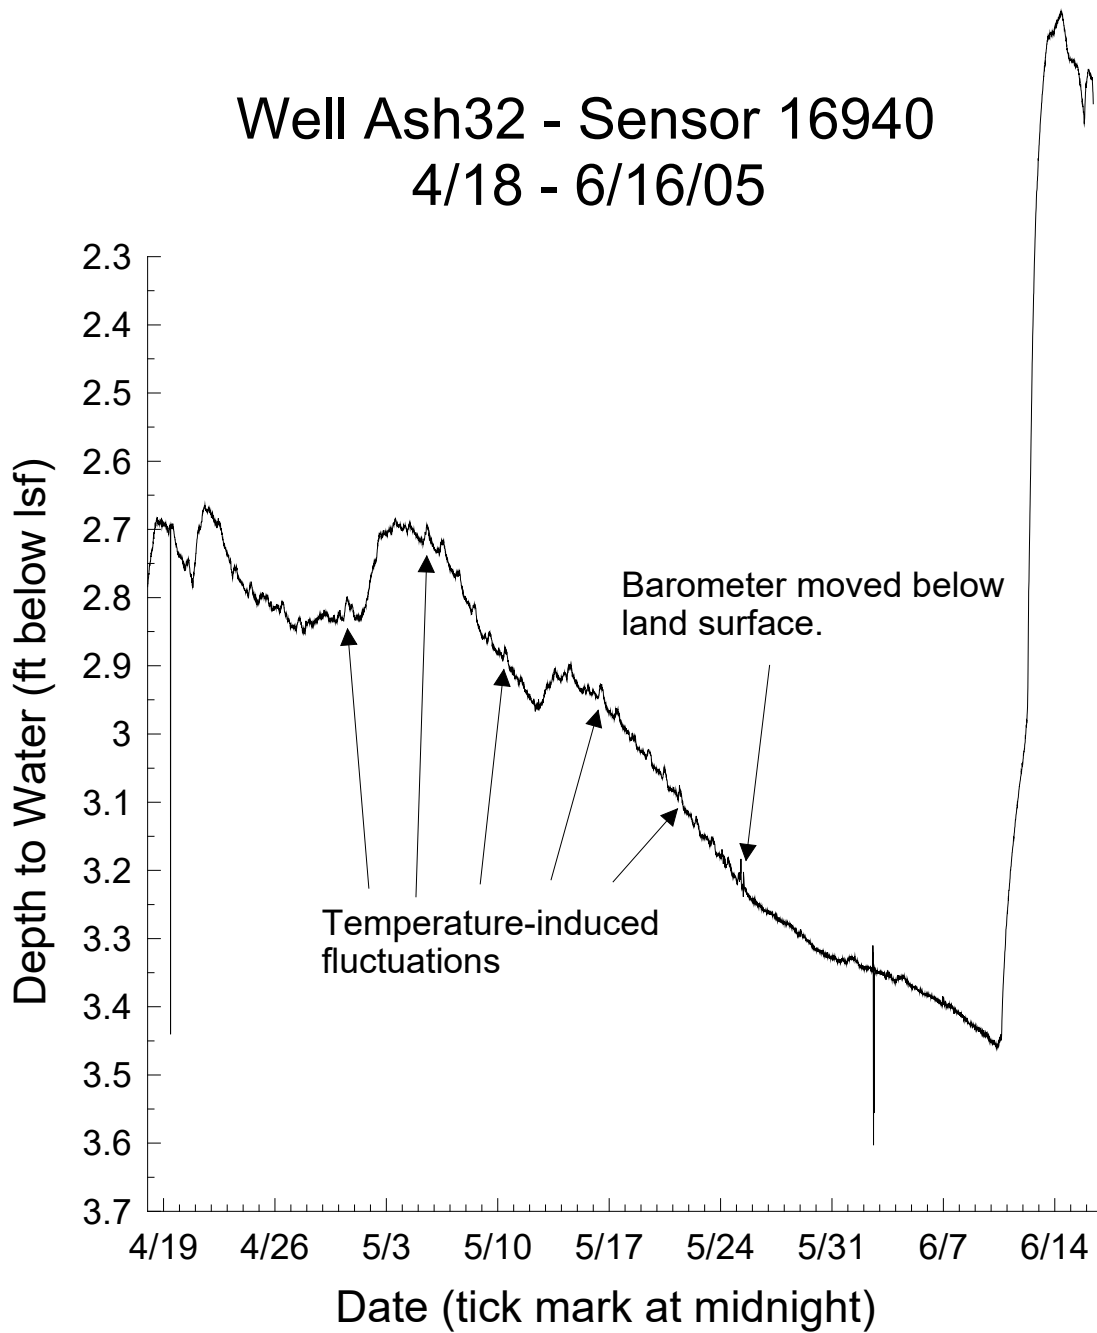
Figure 15 - Depth to water recorded in well Ash32 for the final 60 days of the reporting period (note downward spikes in water-level data at time of downloading as in Figure 14a; barometer [sensor 16977] moved 1.59 ft below lsf on May 25, 2005).

compensation from the data. Our current procedure exploits the fact that water levels at Ash32 are not subject to the variations induced by plant-water use as at the other wells and therefore display a very smooth variation through time (Figures 3b and 15).

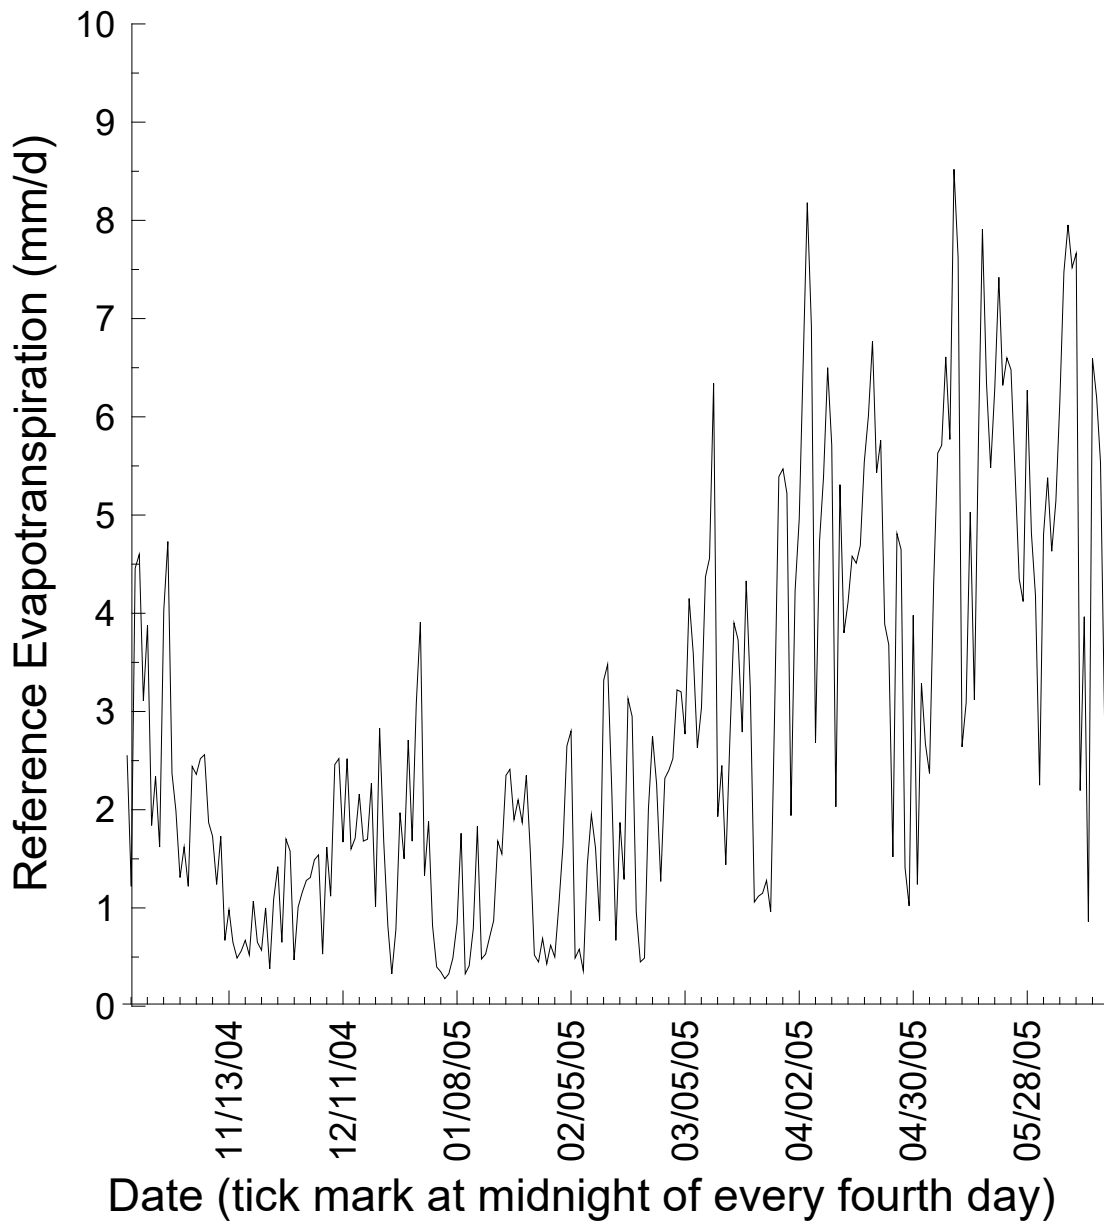
Ashland Weather Station Calculated ET_0

Figure 16 – Calculated reference ET_0 for entire duration of weather station operation during this reporting period.

Figure 16 displays the reference evapotranspiration parameter for the entire period during which the weather station was operating. The decrease in ET_0 in the winter months and the increase in the spring are as expected. The sizable temporal variations in ET_0 observed throughout the period also are as expected and are a product of changing meteorological conditions.

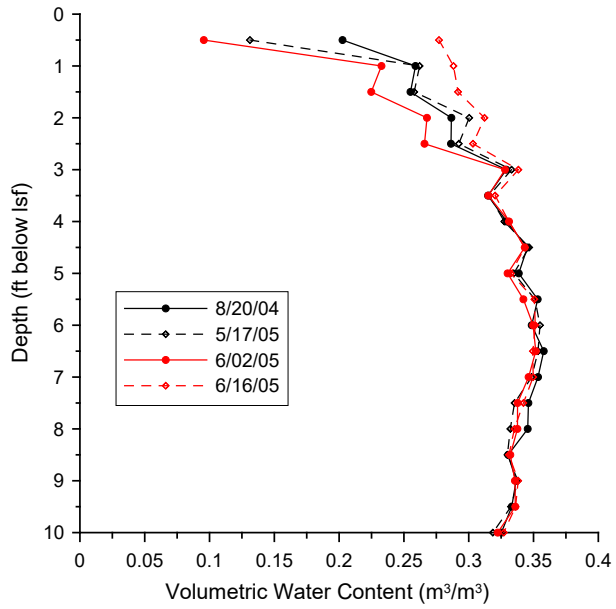
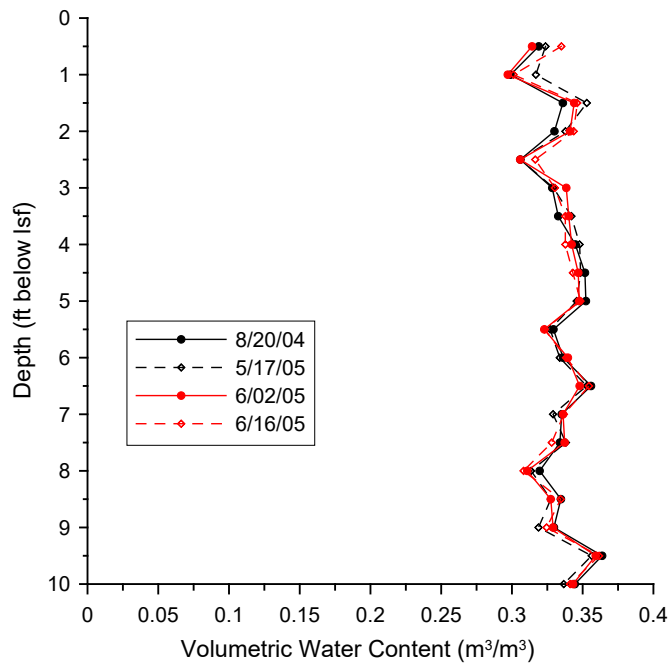
Figure 17 – Volumetric water content versus depth plot from neutron-probe access tube adjacent to well Ash12 (a) and well Ash22 (b).

Figures 17a-b display results of neutron logging at access tubes adjacent to wells Ash12 and Ash22, respectively. The large differences between the moisture content profiles from the Ash12 access tube, particularly in the first foot, are undoubtedly due to the existence of coarse (i.e. rapidly drained) material near the surface (see low EC values near surface in log of Figure 6b). The small differences observed between the moisture content profiles from the Ash22 access tube are consistent with the high EC values (suspected clayey soil zone) observed near the surface at that well (see Figure 8b). These readings may be influenced by salinity as indicated in the previous paragraph. However, the total porosity values below the water table appear reasonable for both access tubes.
