Compact Micro-Imager Interpretation Results

COMPANY: **VESS OIL CORP.**

WELL: **MCCORD 'A' 20H**

FIELD: **BEMIS SHUTTS**

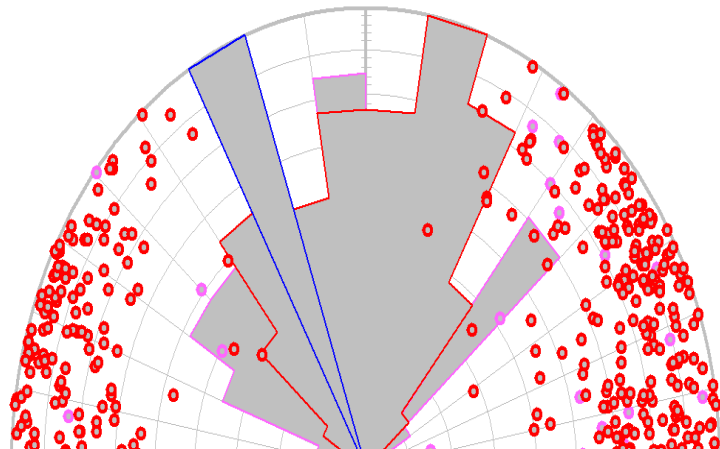
Open_Fracture
Partially_Open_Fracture
Drilling_Induced_Fracture
Healed_Fracture
Fault
(3742-5758)

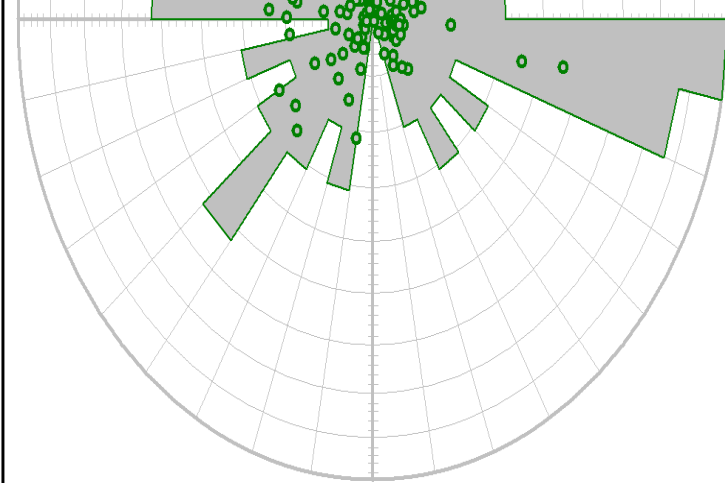
Schmidt Plot (3742-5758)

Bedding Planes (Dip)

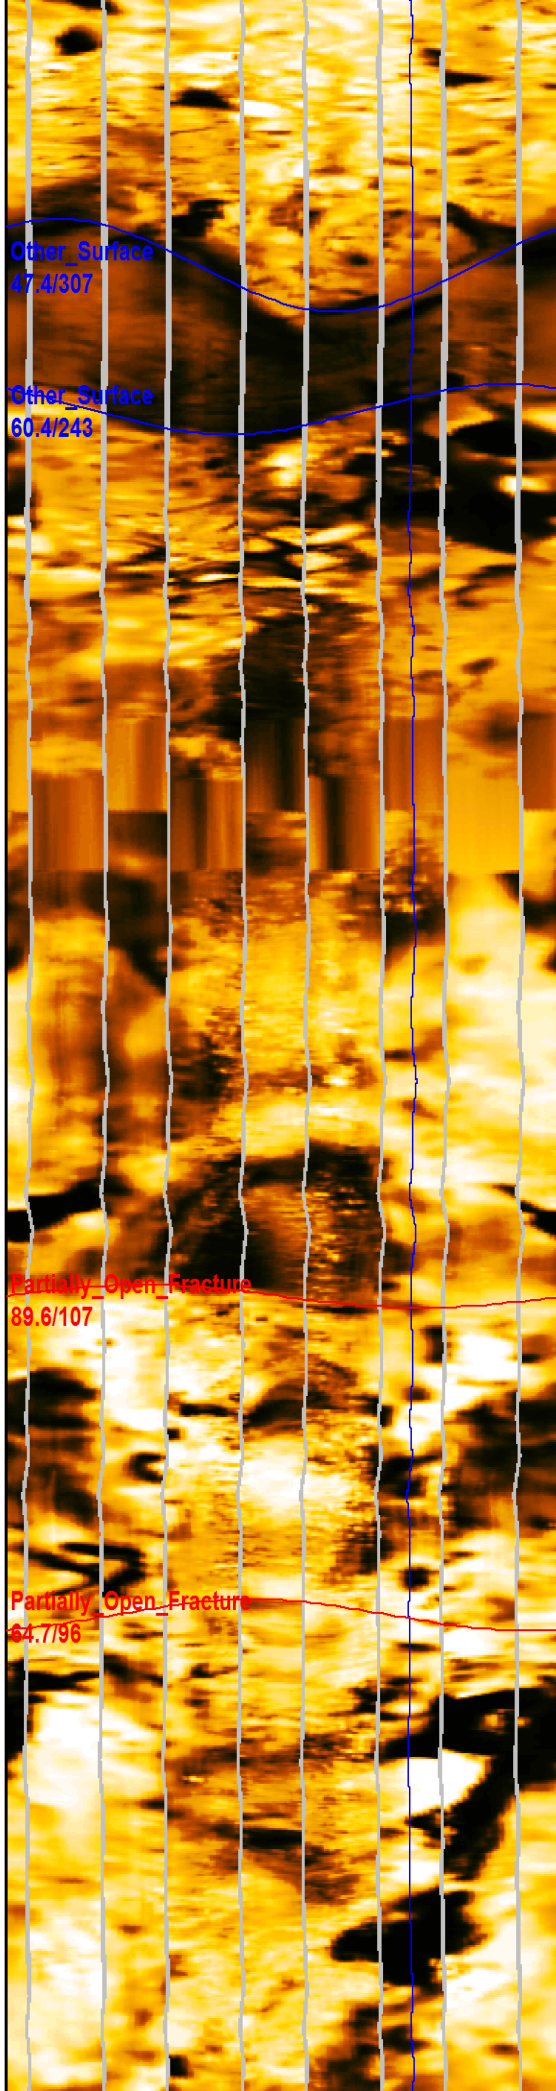
4484
4485
4486
4487
4488
4489
4490
4491
4492
4493
4494
4495
4496
4497
4498
4499
4500
4501
4502

Other_Surface
47.1/307

Other_Surface
60.4/243

Partially_Open_Fracture
64.7/96
