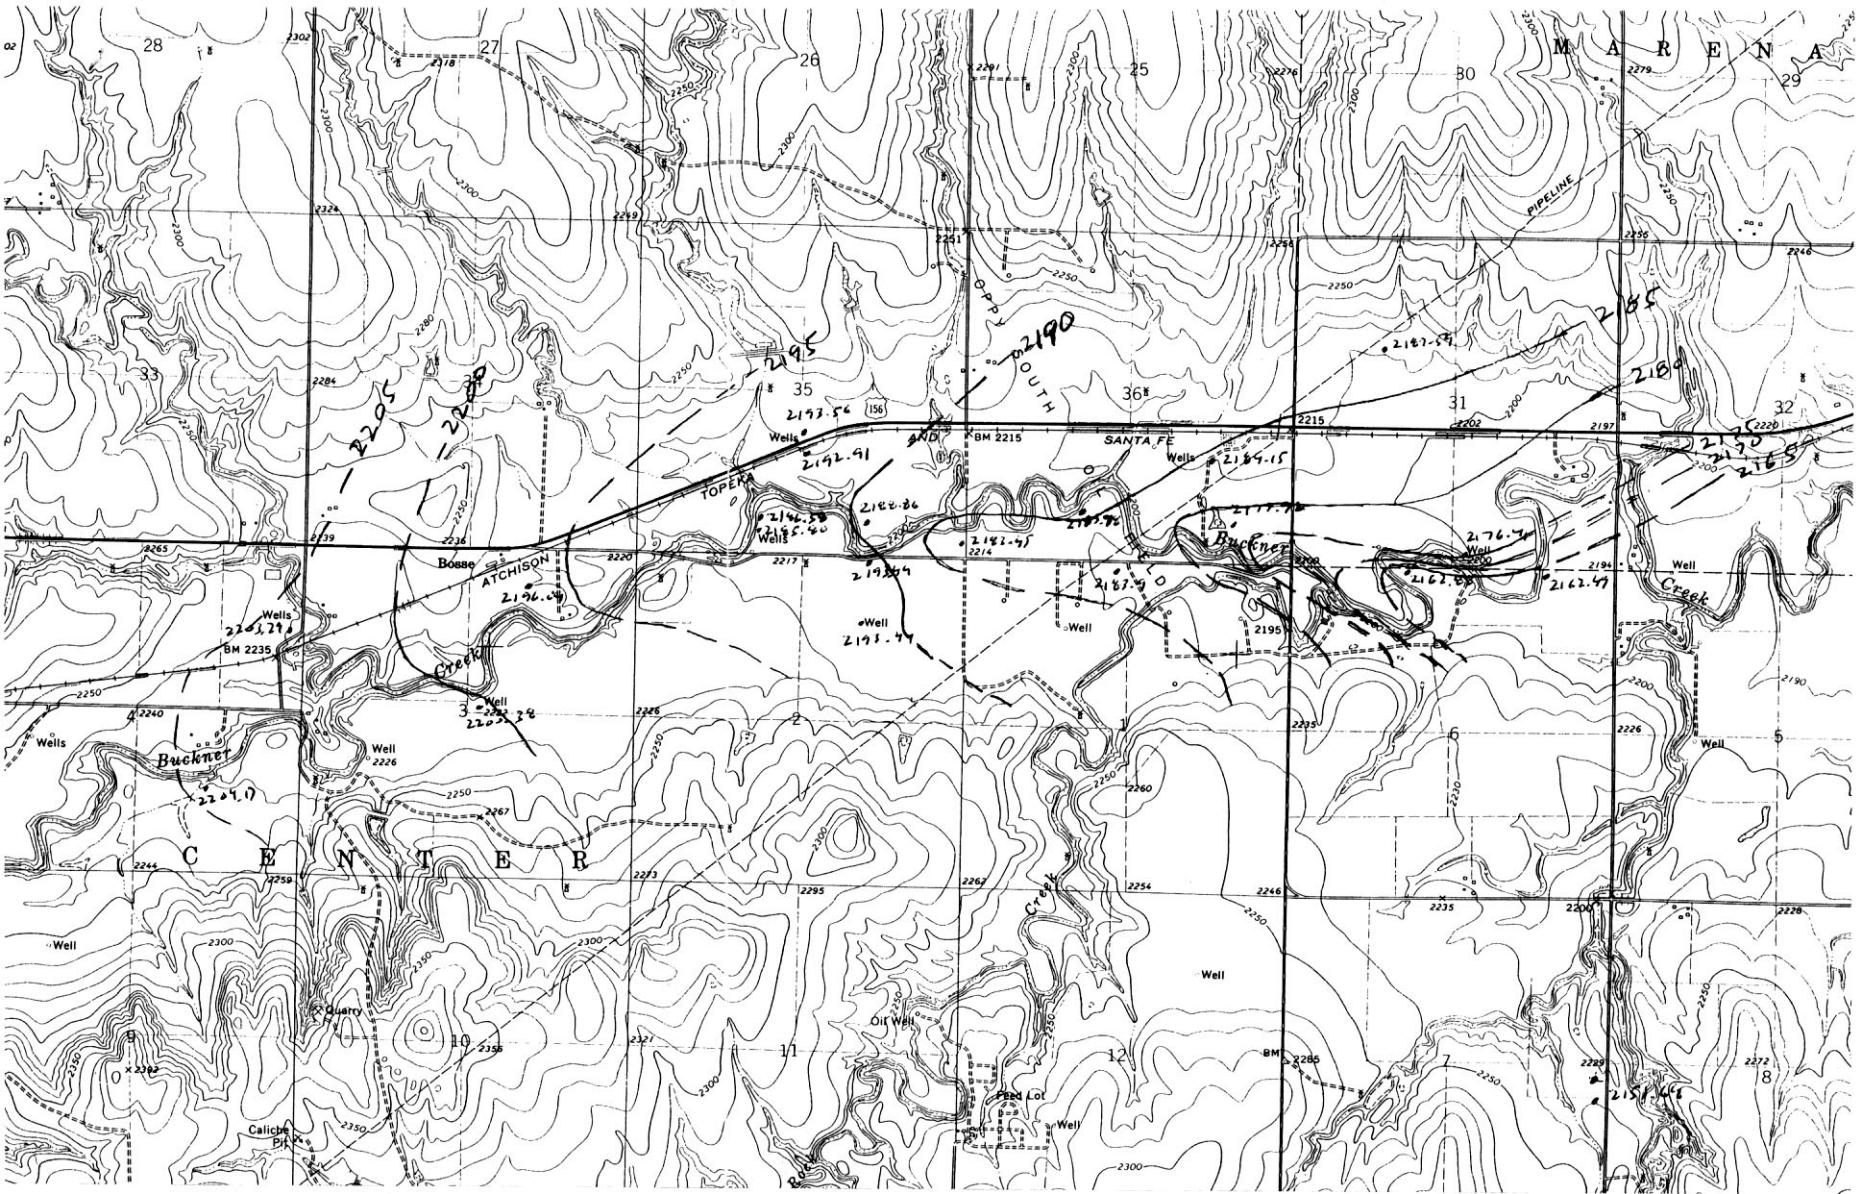
Figure 2. Configuration of the water-table surface in the alluvial aquifer of Buckner Creek from water-level measurements made in March 2000.
